Technical Service Bulletin (TSB)
Flash: Motor Control Processor A (MCP A) Updates 6A1

REFERENCE:	TSB: 08-027-25 REV. B GROUP: 08 - Electrical	Date:	April 29, 2025	REVISION:	08-027-25 REV. A
VEHICLES AFFECTED:	2025 (LB) Dodge Charger This bulletin applies to vehicles built on or before **April 03, 2025 (MDH 0403XX)** equipped with 400V G2500 FR/RR Elec Drive Motors (Sales Code ELD).			MARKET APPLICABILITY:	
				<input checked="" type="checkbox"/> NA	<input checked="" type="checkbox"/> MEA
				<input checked="" type="checkbox"/> SA	<input checked="" type="checkbox"/> IAP
				<input checked="" type="checkbox"/> EE	<input checked="" type="checkbox"/> CH
CUSTOMER SYMPTOM:	Customers must experience a Malfunction Indicator Lamp (MIL) illumination and the vehicle must exhibit/set the following Diagnostic Trouble Code (DTC): <ul style="list-style-type: none"> • P1626-00 - Park Pawl Motor Stuck. The customer may comment on one or more of the following symptoms: <ul style="list-style-type: none"> • Wrench icon is illuminated on the Instrument Panel Cluster (IPC). • Turtle icon illuminated on the IPC. • Reduced power. • Vehicle will not shift out of park.

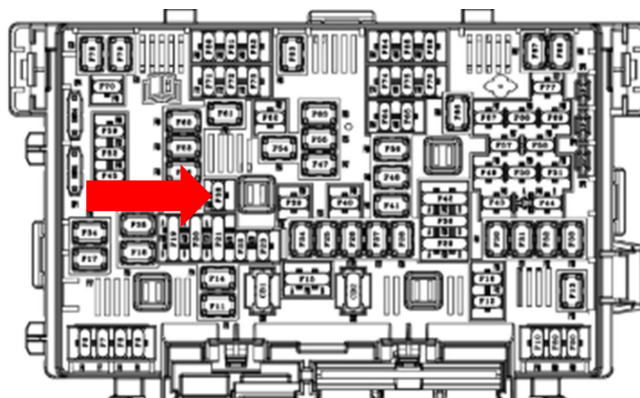
Fig. 3
#38 AGSM Fuse Location

Failure to remove the #38 AGSM fuse will result in damage to the shifter.

6. Remove the PDC cover, locate and remove the #38 AGSM fuse [Fig. 3](#).**

24. **Install the #38 AGSM fuse [Fig. 3](#) and the PDC cover [Fig. 2](#).
25. Position the rear carpet in place.**
26. Connect the cooling fan wire harness connector [Fig. 1](#).
27. Install the front storage bin. Refer to the detailed service procedures available in DealerCONNECT/ ServiceLibrary under: Service Info> 23 - Body / Exterior / Bin, Storage / Installation.
28. Clear any DTCs that may have been set in any modules due to reprogramming. The wiTECH application will automatically present all DTCs after the flash and allow them to be cleared.
