**Technical Service Bulletin (TSB)**  
**Flash: Electronic Vehicle Control Unit (EVCU) Updates 11A1**

| REFERENCE: | TSB: 08-026-25 REV. B<br>GROUP: 08 - Electrical | Date: | April 29, 2025 | REVISION: | 08-026-25 REV. A |
| VEHICLES AFFECTED: | 2024 (LB) Dodge Charger<br>This bulletin applies to vehicles equipped with 400V G2500 FR/RR Elec Drive Motors (Sales Code ELD). | | | MARKET APPLICABILITY:<br><div><div><input checked="" type="checkbox"/> NA</div><div><input checked="" type="checkbox"/> SA</div><div><input checked="" type="checkbox"/> EE</div></div> <div><div><input checked="" type="checkbox"/> MEA</div><div><input checked="" type="checkbox"/> IAP</div><div><input checked="" type="checkbox"/> CH</div></div> | |

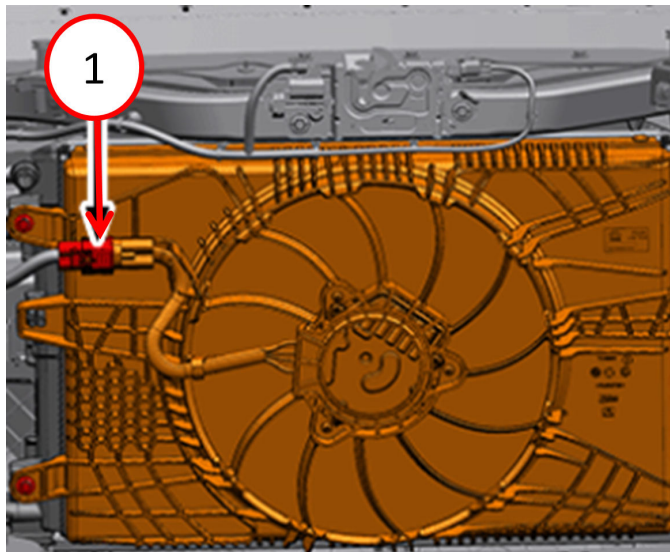
**Fig. 1**  
Cooling Fan Assembly

**NOTE:** The cooling fan must be disconnected to prevent it from powering on, which may interrupt/ abort the flash process.

- Before performing the software reprogramming, it is necessary to make the vehicle safe.
- When performing repairs that directly involve or imply possible contact with live high voltage components/systems, the technician must ensure that the power supply of the high-voltage system is disconnected throughout the operation.
- Only specifically trained technicians qualified to perform repairs on vehicles with high voltage systems under current national laws/regulations are authorized to work on the vehicle.
- Before performing any diagnostic repair work on the vehicle, carefully read and comply with the general instructions for working safely on hybrid/electric vehicles and use suitable general equipment and Personal Protective Equipment (PPE).
- The vehicle must not be connected to a high voltage charger when performing software updates.

4. Disconnect the cooling fan wire harness connector [Fig. 1](#).
