| REFERENCE: | TSB: 08-025-25 REV. B<br>GROUP: 08 - Electrical | Date: | April 29, 2025 | REVISION: | 08-025-25 REV. A |
| VEHICLES AFFECTED: | 2025 (LB) Dodge Charger<br>This bulletin applies to vehicles built on or before **April 03, 2025 (MDH 0403XX)** equipped with 400V G2500 FR/RR Elec Drive Motors (Sales Code ELD). | | | MARKET APPLICABILITY:<br><div><input type="checkbox"/> NA<input type="checkbox"/> MEA</div> <div><input type="checkbox"/> SA<input type="checkbox"/> IAP</div> <div><input type="checkbox"/> EE<input type="checkbox"/> CH</div> | |

| <b>CAUSE:</b> | <b>BPCM software update</b> |

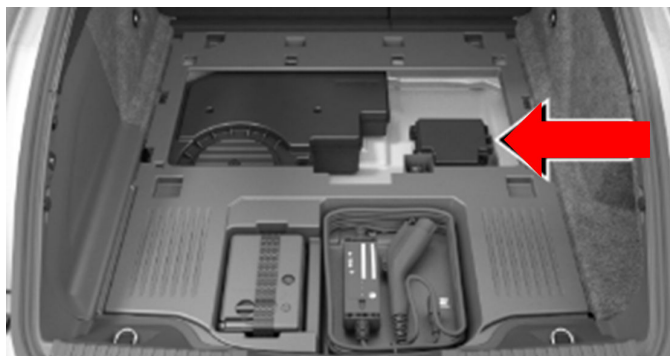
**Fig. 2**  
Rear PDC Location

5. From the rear of the vehicle, pull back the carpet to access the rear Power Distribution Center (PDC) [Fig. 2](#).

24. \*\*Install the #38 AGSM fuse [Fig. 3](#) and the PDC cover [Fig. 2](#).

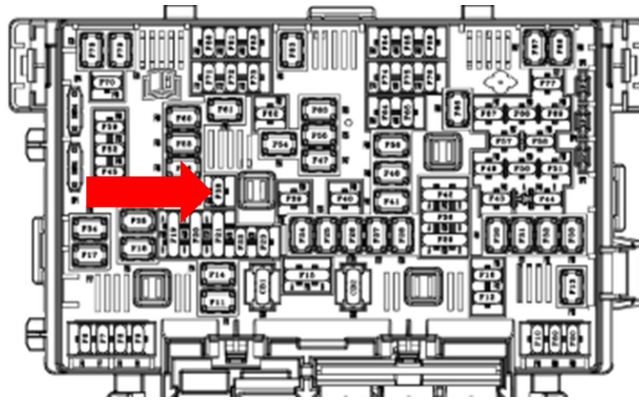
**Fig. 3**  
#38 AGSM Fuse Location

**Failure to remove the #38 AGSM fuse will result in damage to the shifter.**

6. Remove the PDC cover, locate and remove the #38 AGSM fuse [Fig. 3](#).\*\*
