**Technical Service Bulletin (TSB)**  
**Flash: Motor Control Processor A (MCP A) Updates 11A1**

| REFERENCE: | TSB: 08-023-25 REV. B<br>GROUP: 08 - Electrical | Date: | April 29, 2025 | REVISION: | 08-023-25 REV. A |
| VEHICLES AFFECTED: | 2024 (LB) Dodge Charger<br>This bulletin applies to vehicles equipped with 400V G2500 FR/RR Elec Drive Motors (Sales Code ELD). | | | MARKET APPLICABILITY:<br><div><input checked="" type="checkbox"/> NA<input checked="" type="checkbox"/> MEA</div> <div><input checked="" type="checkbox"/> SA<input checked="" type="checkbox"/> IAP</div> <div><input checked="" type="checkbox"/> EE<input checked="" type="checkbox"/> CH</div> | |

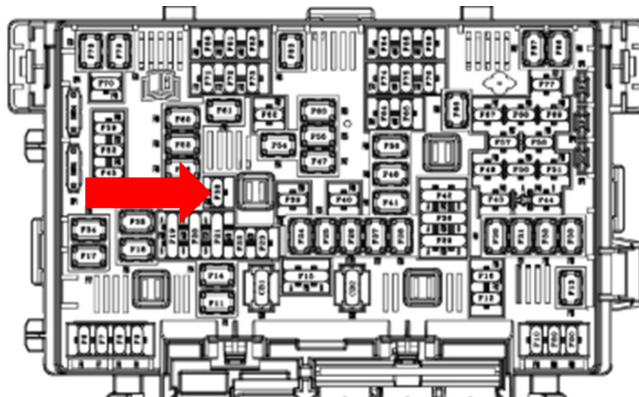
**Fig. 3**  
#38 AGSM Fuse Location

**Failure to remove the #38 AGSM fuse will result in damage to the shifter.**

6. Remove the PDC cover, locate and remove the #38 AGSM fuse [Fig. 3](#).\*\*

24. \*\*Install the #38 AGSM fuse [Fig. 3](#) and the PDC cover [Fig. 2](#).
25. Position the rear carpet in place.\*\*
26. Connect the cooling fan wire harness connector [Fig. 1](#).
27. Install the front storage bin. Refer to the detailed service procedures available in DealerCONNECT/ServiceLibrary under: Service Info> 23 - Body / Exterior / Bin, Storage / Installation.
28. Clear any DTCs that may have been set in any modules due to reprogramming. The wiTECH application will automatically present all DTCs after the flash and allow them to be cleared.
