Technical Service Bulletin (TSB)
Flash: Motor Control Processor B (MCP B) Updates 11A1

REFERENCE:	TSB: 08-013-25 REV. B GROUP: 08 - Electrical	Date:	April 29, 2025	REVISION:	08-013-25 REV. A
VEHICLES AFFECTED:	2024 (KM) Jeep Wagoneer S This bulletin applies to vehicles equipped with 400V G2500 FR/RR Elec Drive Motors (Sales Code ELD).			MARKET APPLICABILITY:	
				<input checked="" type="checkbox"/> NA	<input checked="" type="checkbox"/> MEA
				<input checked="" type="checkbox"/> **SA	<input checked="" type="checkbox"/> IAP
				<input checked="" type="checkbox"/> EE	<input checked="" type="checkbox"/> CH**
CUSTOMER SYMPTOM:	<p>Customers may experience a Malfunction Indicator Lamp (MIL) illumination and the vehicle may exhibit/set the following Diagnostic Trouble Code (DTC):</p> <ul style="list-style-type: none"> • P1626-00 - Park Pawl Motor Stuck. <p>Customers may also comment on one or more of the following:</p> <ul style="list-style-type: none"> • Wrench lamp on in the Instrument Panel Cluster (IPC). • Not able to move the shifter out of Park. • Vehicle has reduced power. <p>This bulletin also includes the following software enhancement:</p> <ul style="list-style-type: none"> •

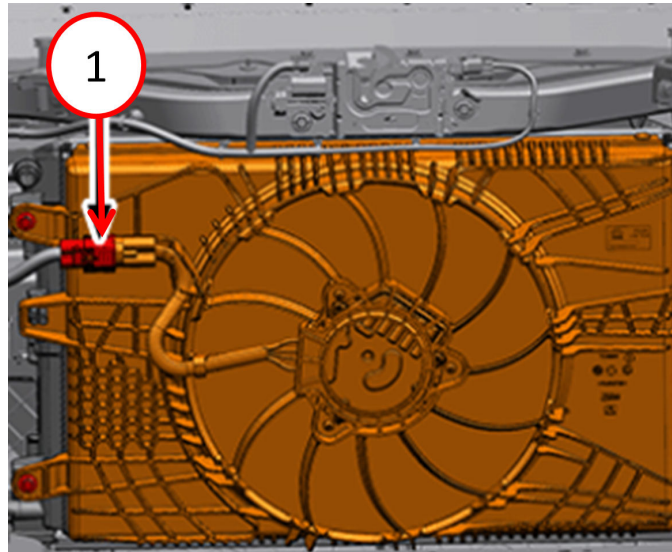
Fig. 1
Cooling Fan Assembly

NOTE: The cooling fan must be disconnected to prevent it from powering on, which may interrupt/ abort the flash process.

4. Disconnect the cooling fan wire harness connector [Fig. 1](#).**

22. **Connect the cooling fan wire harness connector [Fig. 1](#).
