Technical Service Bulletin (TSB)
Flash: Motor Control Processor A (MCP A) Updates 11A1

REFERENCE:	TSB: 08-010-25 REV. C GROUP: 08 - Electrical	Date:	April 29, 2025	REVISION:	08-010-25 REV. B
VEHICLES AFFECTED:	2024 (KM) Jeep Wagoneer S This bulletin applies to vehicles equipped with 400V G2500 FR/RR Elec Drive Motors (Sales Code ELD).			MARKET APPLICABILITY:	
				<input checked="" type="checkbox"/> NA	<input checked="" type="checkbox"/> MEA
				<input checked="" type="checkbox"/> **SA	<input checked="" type="checkbox"/> IAP
				<input checked="" type="checkbox"/> EE	<input checked="" type="checkbox"/> CH**
CUSTOMER SYMPTOM:	Customers may experience a Malfunction Indicator Lamp (MIL) illumination and the vehicle may exhibit/set the following Diagnostic Trouble Code (DTC): <ul style="list-style-type: none"> • P1626-00 - Park Pawl Motor Stuck. Customers may also comment on one or more of the following: <ul style="list-style-type: none"> • Wrench lamp on in the Instrument Panel Cluster (IPC). • Not able to move the shifter out of Park. • Vehicle has reduced power. This bulletin also includes the following software enhancement: <ul style="list-style-type: none"> • Software enhancement

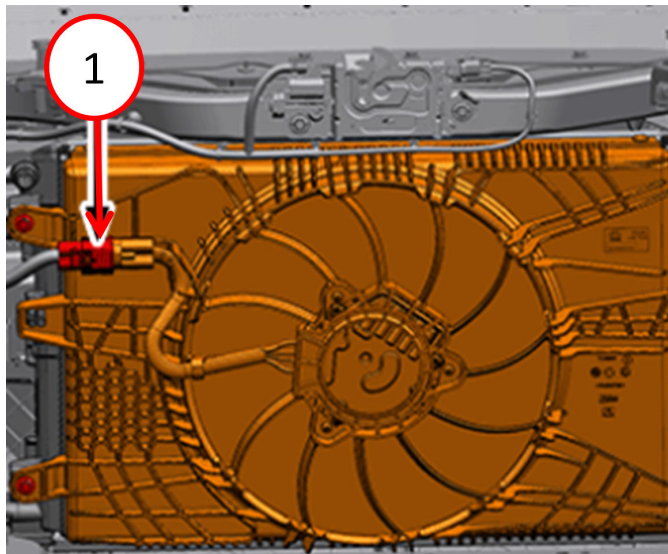
Fig. 1
Cooling Fan Assembly

1 - Wire Harness To Disconnect/Connect

4. Disconnect the cooling fan wire harness connector [Fig. 1](#).**

NOTE: If the Wheel End Disconnect Position Learn routine is not successful, roll the vehicle slightly forward so that the wheel end disconnect actuators can align on the spline before attempting to perform the routine again.
22. **Connect the cooling fan wire harness connector [Fig. 1](#).
23. Install the front storage bin. Refer to the detailed service procedures available in DealerCONNECT/ ServiceLibrary under: Service Info> 23 - Body / Exterior / Bin, Storage / Installation.**
24. Clear any DTCs that may have been set in any modules due to reprogramming. The wiTECH application will automatically present all DTCs after the flash and allow them to be cleared.
