Technical Service Bulletin (TSB)
Flash: Motor Control Processor B (MCP B) Updates 6A1

REFERENCE:	TSB: 08-024-25 REV. B GROUP: 08 - Electrical	Date:	April 29, 2025	REVISION:	08-024-25 REV. A
VEHICLES AFFECTED:	2025 (LB) Dodge Charger This bulletin applies to vehicles built on and before **April 03, 2025 (MDH 0403XX)** equipped with 400V G2500 FR/RR Elec Drive Motors (Sales Code ELD).	MARKET APPLICABILITY:		<input checked="" type="checkbox"/> NA	<input checked="" type="checkbox"/> MEA
				<input checked="" type="checkbox"/> SA	<input checked="" type="checkbox"/> IAP
				<input checked="" type="checkbox"/> EE	<input checked="" type="checkbox"/> CH
CUSTOMER SYMPTOM:	<p>Customers must experience a Malfunction Indicator Lamp (MIL) illumination and the vehicle must exhibit/set the following Diagnostic Trouble Code (DTC):</p> <ul style="list-style-type: none"> ● P1626-00 - Park Pawl Motor Stuck. <p>The customer may comment on one or more of the following symptoms:</p> <ul style="list-style-type: none"> ● Wrench icon is illuminated on the Instrument Panel Cluster (IPC). ● Turtle icon illuminated on the IPC. ● Reduced power. ● Vehicle will not shift out of park.

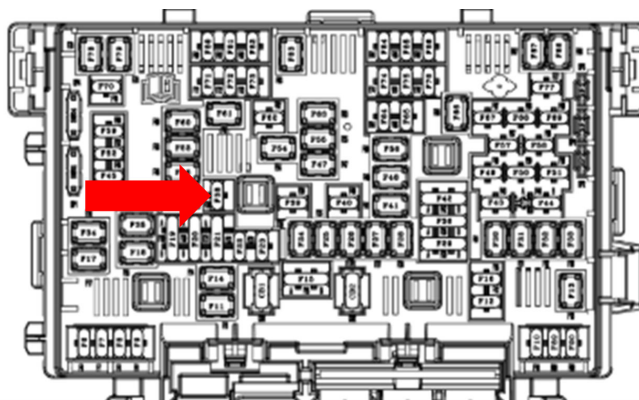
Fig. 3
#38 AGSM Fuse Location

Failure to remove the #38 AGSM fuse will result in damage to the shifter.

6. Remove the PDC cover, locate and remove the #38 AGSM fuse [Fig. 3](#).**

24. **Install the #38 AGSM fuse [Fig. 3](#) and the PDC cover [Fig. 2](#).
25. Position the rear carpet in place.**
26. Connect the cooling fan wire harness connector [Fig. 1](#).
27. Install the front storage bin. Refer to the detailed service procedures available in DealerCONNECT/ ServiceLibrary under: Service Info> 23 - Body / Exterior / Bin, Storage / Installation.
28. Clear any DTCs that may have been set in any modules due to reprogramming. The wiTECH application will automatically present all DTCs after the flash and allow them to be cleared.
