# Technical Service Bulletin

<b>Topic</b>	Poor Engine Running Complaints (Misfires) Petrol Engines Only
<b>Market area</b>	Australia E04 Bentley rest Asia and Australia (6E04),China 723 Volkswagen (Anhui) Automotive CO (6723),China 796 VW Import Comp. Ltd (Vico), Beijing (6796),Germany E02 Bentley rest Europe (6E02),Japan E03 Bentley Japan (6E03),Korea, (South) E08 Bentley South Korea (6E08),United Arab Emirates E06 Bentley Middle East and Africa (6E06),United Kingdom E01 Bentley UK (6E01),United States E05 Bentley USA and rest America (6E05)
<b>Brand</b>	Bentley
<b>Transaction No.</b>	2051187/11
<b>Level</b>	EH
<b>Status</b>	Released for publishing
<b>Release date</b>	Mar 28, 2025

## Technical Background

Technical Product Information (TPI) to assist retailers when diagnosing poor engine running or misfires

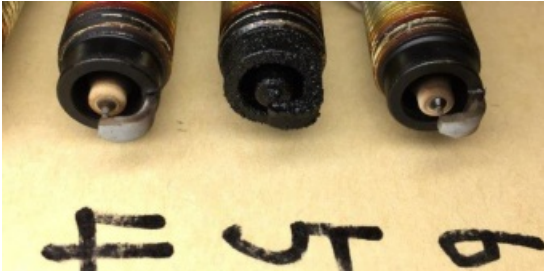
If components are removed and show signs of significant carbon deposit or oil contamination please continue to section 4 - Figure 1

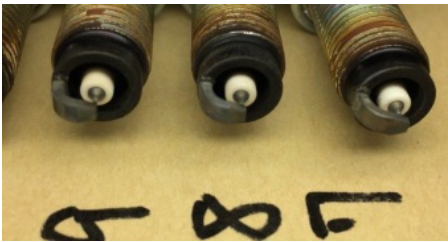
Figure 2

Images accompanying a DISS query must be of a quality shown in Figures 2 and 3
