Technical Service Bulletin

Topic	Rear seat massage function malfunction Bentayga Series 17MY - 25MY
Market area	Bentley: worldwide (2WBE)
Brand	Bentley
Transaction No.	2068981/2
Level	EH
Status	Released for publishing
Release date	Apr 7, 2025

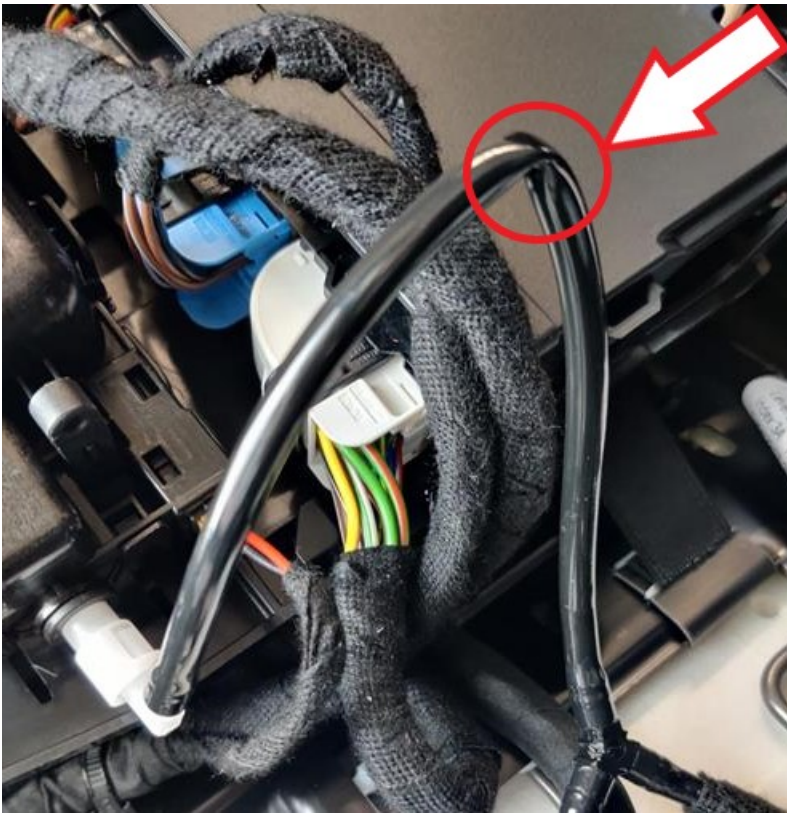
Figure 1

- Pneumatic massage pads
- Air supply lines checking for bends/kinks (Figure 1 shows an example)
- Disconnected air supply lines
- Air leaks
- Referring to the applicable wiring diagram - Conduct a wiring integrity check of the applicable electrical circuits

- In the event an air supply line is found to be bent/kinked the operative should attempt to reposition the air supply line

- If this is not possible (Air supply line is damaged after repositioning) go to Step 5

5) Referring to the applicable Rep.Gr - Replace the applicable component
