# Technical Service Bulletin

<b>Topic</b>	Water ingress into the rear boot or lid   Bentayga Series   17MY - 25MY
<b>Market area</b>	Australia E04 Bentley rest Asia and Australia (6E04),China 723 Volkswagen (Anhui) Automotive CO (6723),China 796 VW Import Comp. Ltd (Vico), Beijing (6796),Germany E02 Bentley rest Europe (6E02),Japan E03 Bentley Japan (6E03),Korea, (South) E08 Bentley South Korea (6E08),Russian Federation 935 Volkswagen Group RUS (6935),United Arab Emirates E06 Bentley Middle East and Africa (6E06),United Kingdom E01 Bentley UK (6E01),United States E05 Bentley USA and rest America (6E05)
<b>Brand</b>	Bentley
<b>Transaction No.</b>	2068829/3
<b>Level</b>	EH
<b>Status</b>	Released for publishing
<b>Release date</b>	Apr 7, 2025

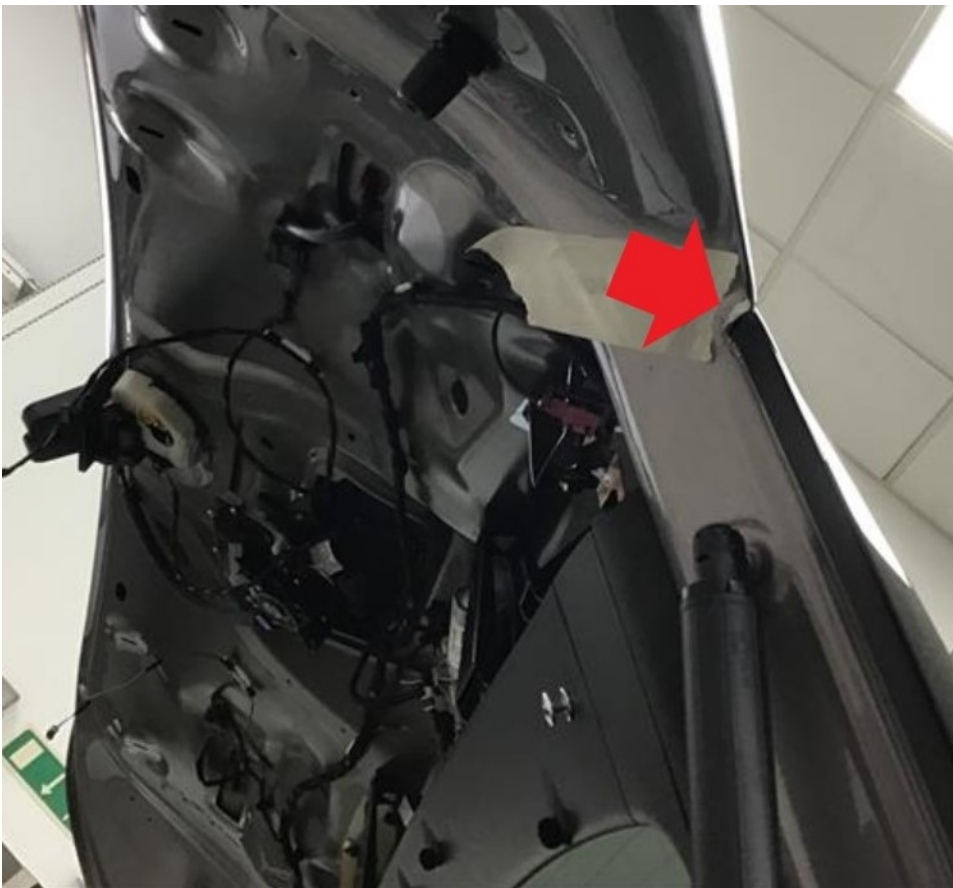
- 1) Referring to Figures 1 and 2 (below the rear lid strut) check to confirm the sealant is present and in a good condition at the location shown (right hand side)

HINT: Figure 1 shows the rear lid trim removed, however the rear lid trim does not require removal for this operation

2) In the event that sealant is missing from the locations shown in Figure 2 (left and/or right hand side)

Different locations on the rear lid the operative should clean/prepare the areas concerned and apply sealant (See parts information) to the applicable locations

- Once sealant has been applied conduct a local paint repair in the location in which sealant was missing

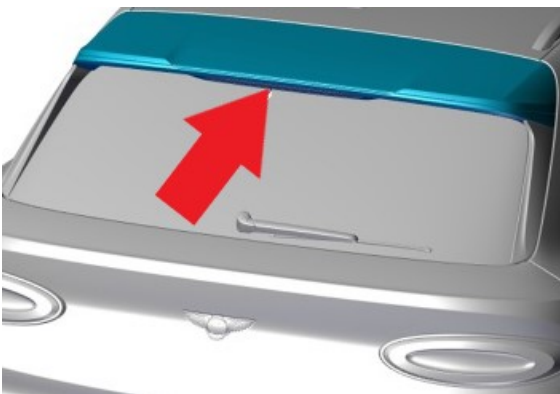
- Figure 3 - Rear spoiler

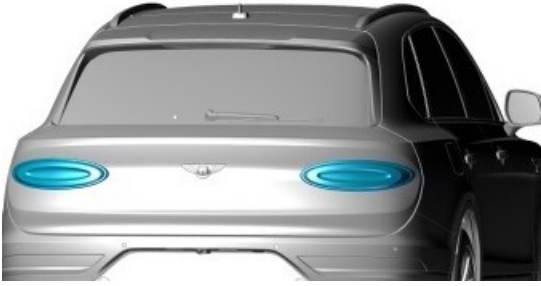
- Figure 4 - Rear lamps

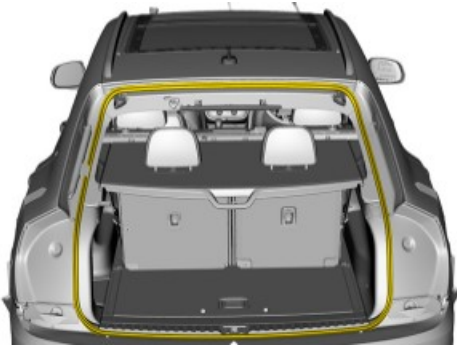
- Figure 6 - Tailgate seal - Refer to Rep.Gr 55 to confirm the seal is fitted correctly and also confirm the seal is not damaged or distorted

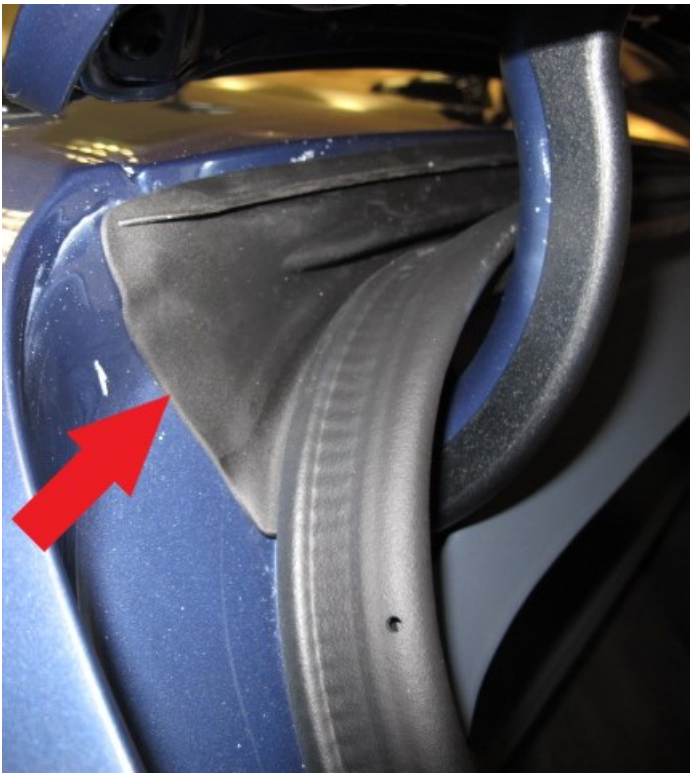
- Figure 7 - Upper water deflector – Check to confirm the upper water deflector is fitted correctly and not damaged/distorted

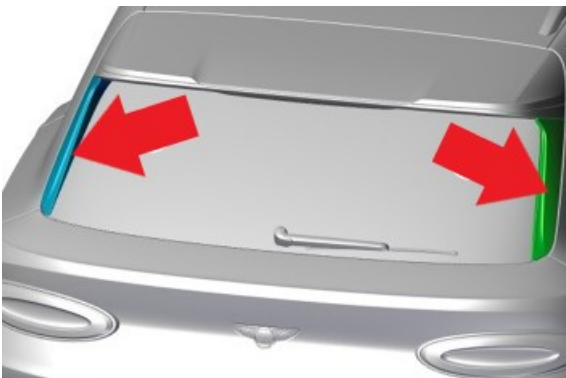
Figure 8

- Rear spoiler side strakes (Figure 8) - Check to confirm the side strakes are secure and water is not leaking past the location tang seals

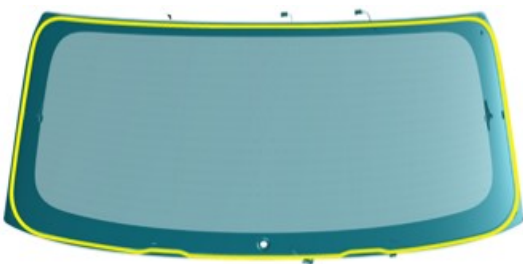
- Rear window glass (Figure 9) - Apply water in the locations shown (yellow line) to confirm the rear window glass is not leaking due to missing sealant

In the event that water ingress is suspected at the location shown in Figure 9 please raise a DISS query and await a response before conducting any further work
