To: **After Sales Official Network**  
Object: **BL4.6 BL Update PN\_47B990100C\_Rev\_0131\_0132**  
Date: **04/04/2025**  
Pages: **19**

**Campaign code:**  
L74X-A.11.25

**Campaign name:**  
BL4.6 Update PN\_47B990100C\_Rev\_0131\_0132

**Model:**  
Revuelto

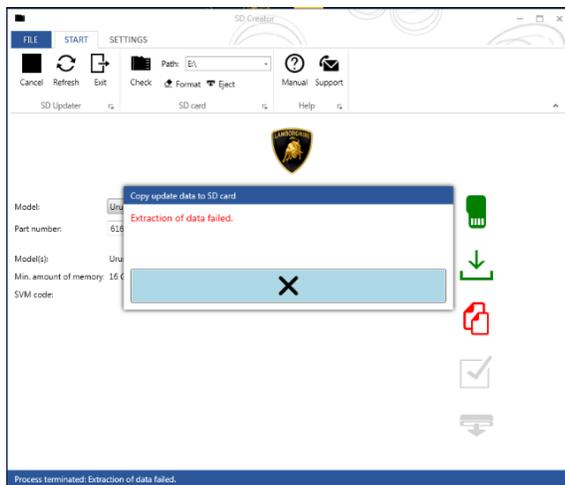
If the error shown in the following image occurs in the download from SD Creator, perform the instructions at the end of this document, in Trouble shooting section.

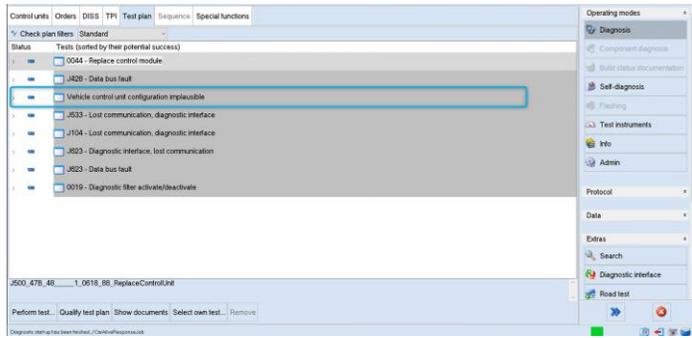
24. Check the DTCs from the ECU 0019: If the DTC “**C12A5F0: Vehicle electrical system configuration implausible**” is present and is in “active” status, please perform the GFF “**Vehicle configuration implausible**” from the Test Plan, as shown below:

Entries in event memory	
Number:	C12A5F0: Vehicle electrical system configuration implausible
Error type 2:	active/static
Symptom:	8519691
Status:	00001001

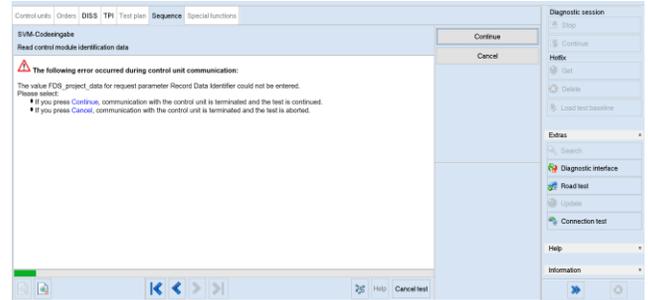
42. If the following error screen is displayed, the error does not indicate an issue, please press “Continue” and continue with the campaign.

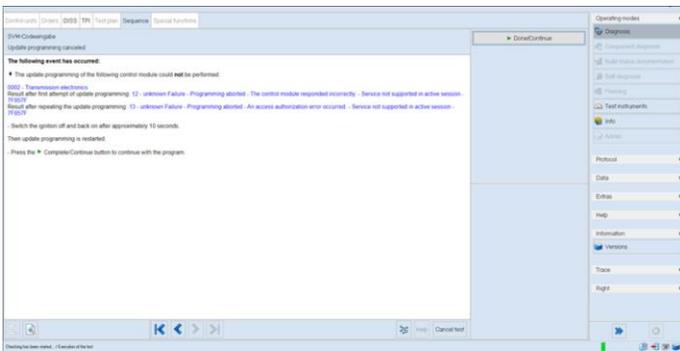
b. If appear the following screens (ECU02 update failed):

Please, follow the instructions displayed: switch the ignition OFF and back ON after 10 seconds and then click "Done/Continue" to continue.

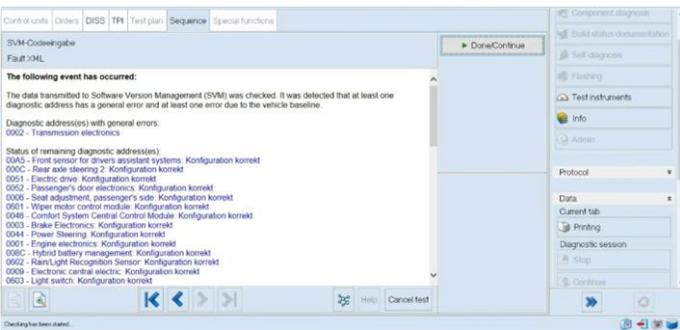
c. If appear the following screen at the end of the function (ECU02 update failed):

Please, execute the following steps:

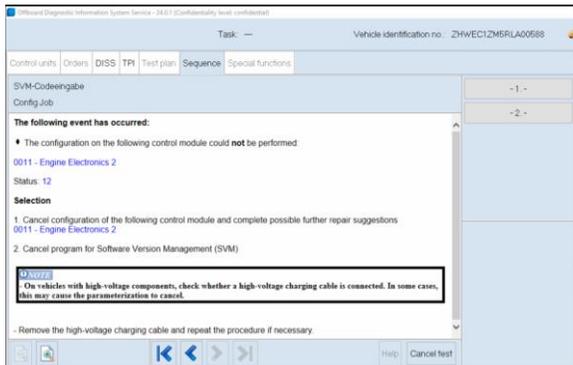
- **8118** → please perform a sleep cycle. Be sure the control unit 5F has been updated to correct software (see previous steps). Check the software level via 5f – control unit identification and compare it to the reference table. Repeat SVM code and contact Technical Support if not resolved.
- **8037** → Please check your O.D.I.S Service version and hotfix as indicated in “Preliminary operation” section.
- **9999** → for the owners of the new D3 Edge Box, please refer to the informative bulletin BL.08.24 to check the correct O.D.I.S Service connection setup.
- **ECU 0011 - Status 12** → the error does not indicate an issue and can be continue with the next step of the campaign. Please, select **option 1** to go ahead.

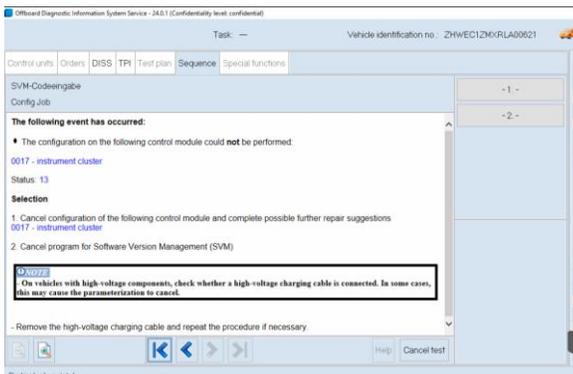
- **ECU 0017 - Status 13** → the error does not indicate an issue and can be continue with the next step of the campaign. Please, select **option 1** to go ahead

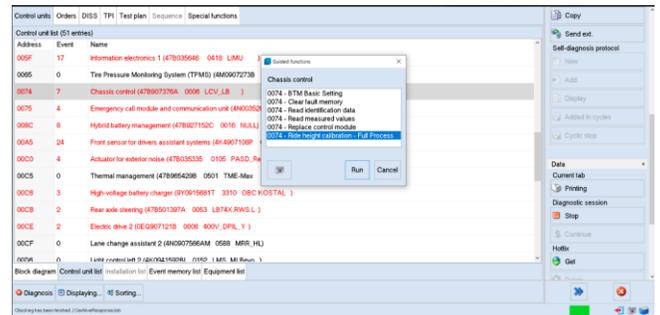
- **ECU0074 → C10C500: Basic setting (deflected) not performed:** please, from the ECU 0074, execute the guided function “74 - Ride hide full process”

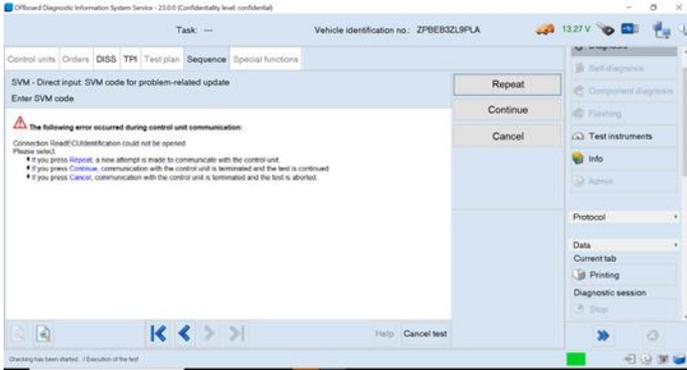
**A.** If the following error screen is displayed, abort the guided function by clicking on “Cancel Test” and contact Technical Support.

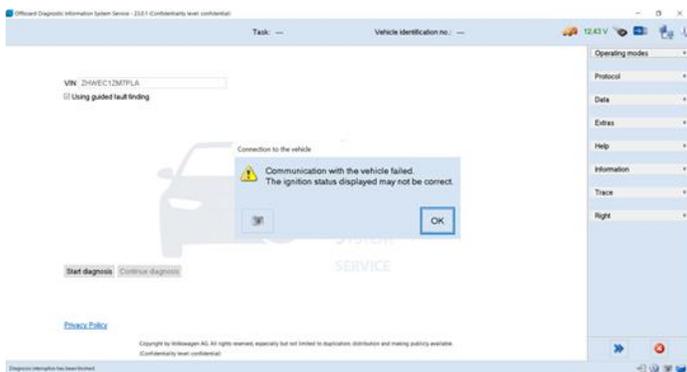
**B.** If an error is displayed that regards the hardware interface, and the "connection to vehicle" and "key state" icons appear as shown in the figure below:

- Click “Cancel”;
- Repeat installation of the interface VAS6154/6154A/6154B for the instructions in procedure (\*) “Checking the VAS 6154”, selecting the right-hand “Extras” menu in O.D.I.S. Service and clicking on the “Diagnostic interface” button.

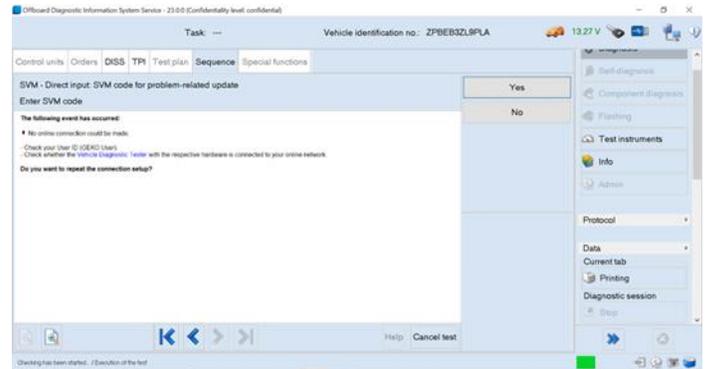
**C.** If the following connection error is displayed like in the following example screenshots:

- It is not possible to connect to the central server; check that your laptop is correctly connected to the Internet and retry by clicking on “Yes” or “Done/continue”, as appropriate.

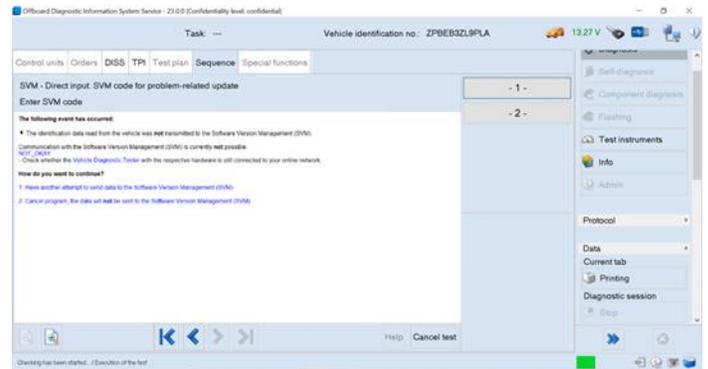
**D.** If the connection is dropped during the target/actual comparison during the SVM procedure:

- It is not possible to connect to the central server; check that your laptop is correctly connected to the Internet and retry by clicking on “I”.

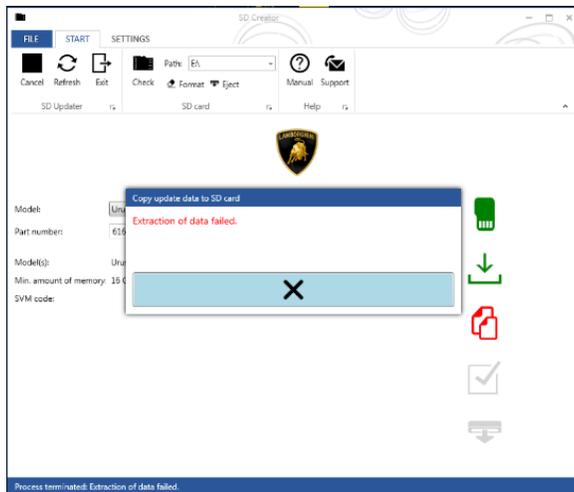
If the following error should occur, it is necessary to follow the instructions given in BI.25.18 (Rev.02), which can be downloaded on the Lamborghini HUB portal:
