L74X-
A.05.25

To: After Sales Official Network
Object: BL5.2 BL Update PN_47B990100D_REV0101
Date: 03/04/2025
Pages: 15

Campaign name:
BL5.2 BL Update PN_47B990100D_REV0101

Model:
Revuelto

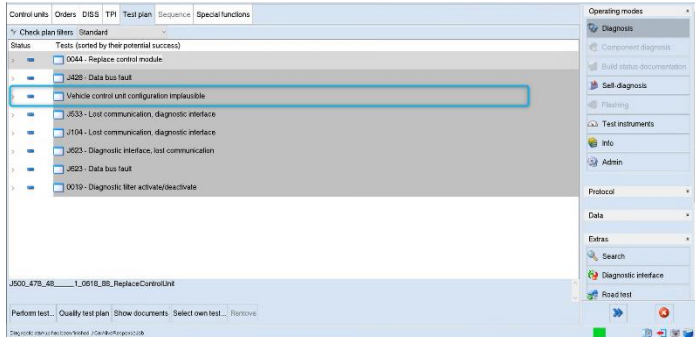
- 1. Check the DTCs from the ECU 0019: If the DTC **“C12A5F0: Vehicle electrical system configuration implausible”** is present and is in **“active”** status, please perform the GFF **“Vehicle configuration implausible”** from the Test Plan, as shown below:

Entries in event memory	
Number:	C12A5F0: Vehicle electrical system configuration implausible
Error type 2:	active/static
Symptom:	8519651
Status:	0001001

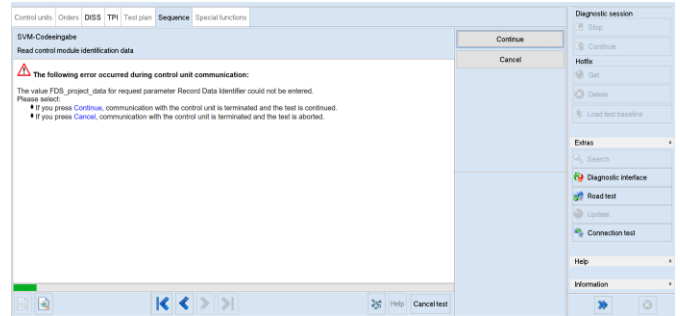
19. If the following error screen is displayed, the error does not indicate an issue, please press “Continue” and continue with the campaign.

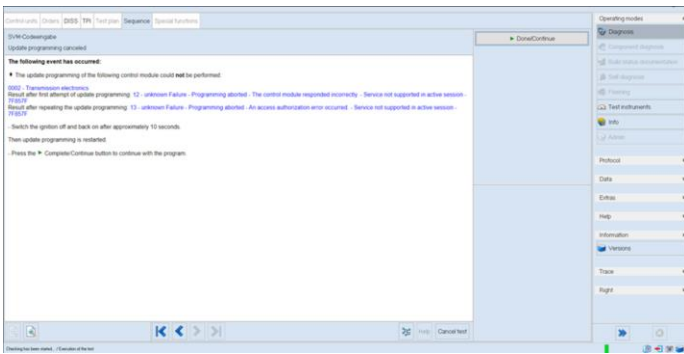
b. If appear the following screens (ECU02 update failed):

Please, follow the instructions displayed: switch the ignition OFF and back ON after 10 seconds and then click "Done/Continue" to continue.

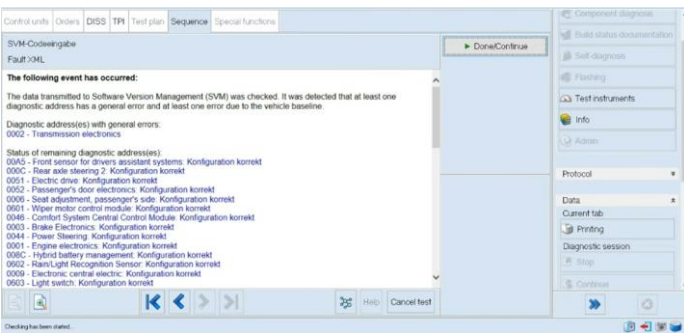
c. If appear the following screen at the end of the function (ECU02 update failed):

Please, execute the following steps:

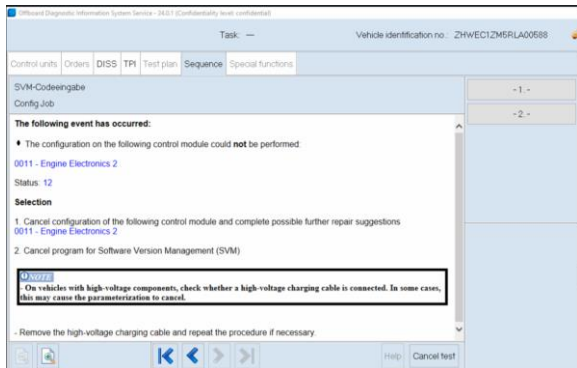
- **8118** → please perform a sleep cycle. Be sure the control unit 5F has been updated to correct software (see previous steps). Check the software level via 5f – control unit identification and compare it to the reference table. Repeat SVM code and contact Technical Support if not resolved.
- **8037** → Please check your O.D.I.S Service version and hotfix as indicated in “Preliminary operation” section.
- **9999** → for the owners of the new D3 Edge Box, please refer to the informative bulletin BL.08.24 to check the correct O.D.I.S Service connection setup.
- **ECU 0011 - Status 12** → the error does not indicate an issue and can be continue with the next step of the campaign. Please, select **option 1** to go ahead.

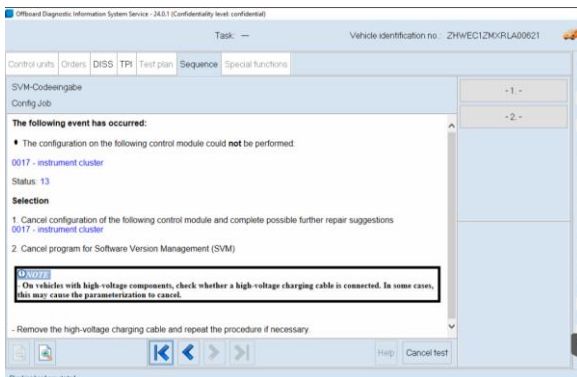
- **ECU 0017 - Status 13** → the error does not indicate an issue and can be continue with the next step of the campaign. Please, select **option 1** to go ahead

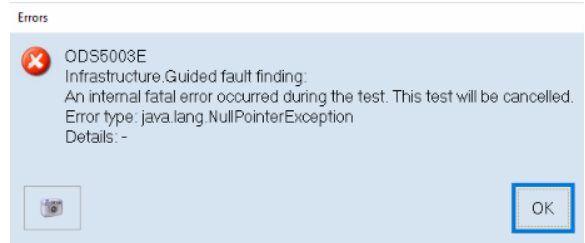
- **ODS5003E** → If the following screen appear please close and repeat the SVM-Code.

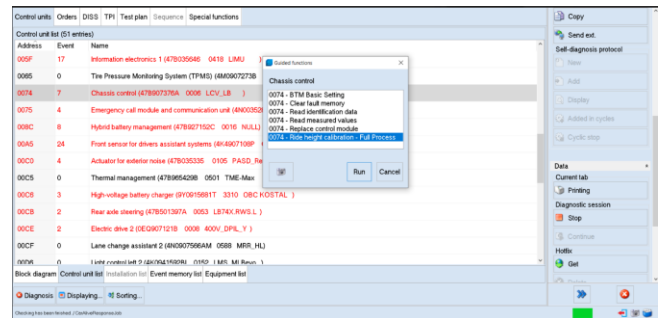
- **ECU0074 → C10C500: Basic setting (deflected) not performed:** please, from the ECU 0074, execute the guided function “74 - Ride hide full process”

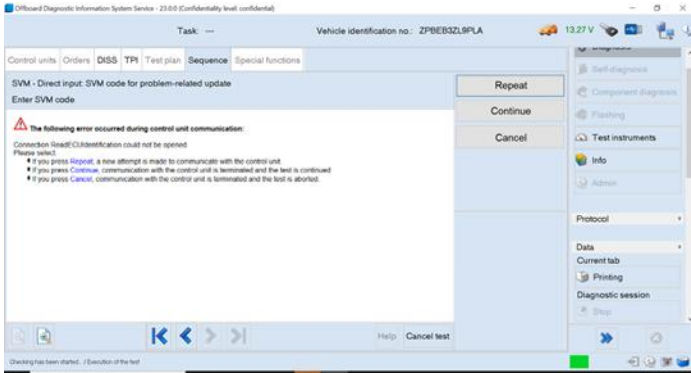
A. If the following error screen is displayed, abort the guided function by clicking on “Cancel Test” and contact Technical Support.

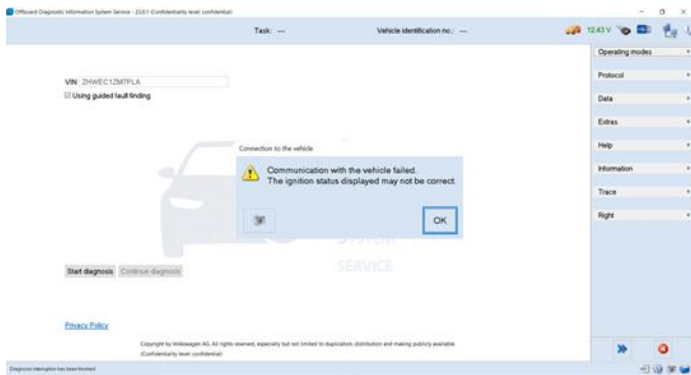
B. If an error is displayed that regards the hardware interface, and the "connection to vehicle" and "key state" icons appear as shown in the figure below:

- Click “Cancel”;
- Repeat installation of the interface VAS6154/6154A/6154B for the instructions in procedure (*) “Checking the VAS 6154”, selecting the right-hand “Extras” menu in O.D.I.S. Service and clicking on the “Diagnostic interface” button.

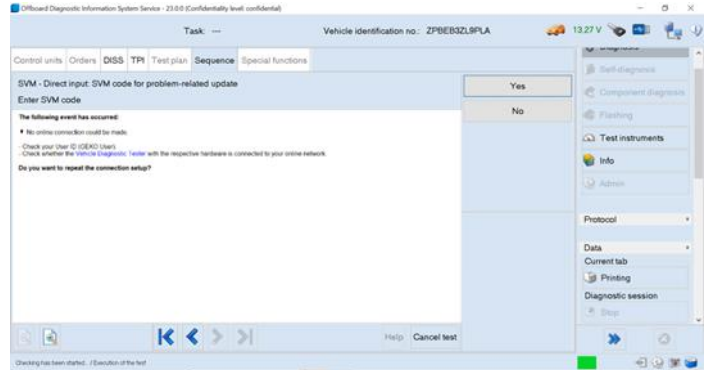
C. If the following connection error is displayed like in the following example screenshots:

- It is not possible to connect to the central server; check that your laptop is correctly connected to the Internet and retry by clicking on “Yes” or “Done/continue”, as appropriate.

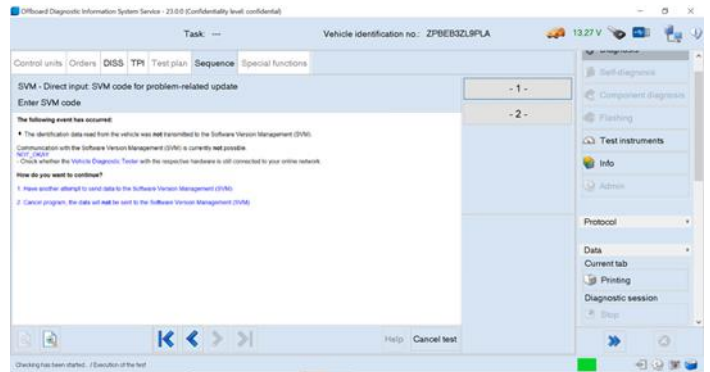
D. If the connection is dropped during the target/actual comparison during the SVM procedure:

- It is not possible to connect to the central server; check that your laptop is correctly connected to the Internet and retry by clicking on “I”.

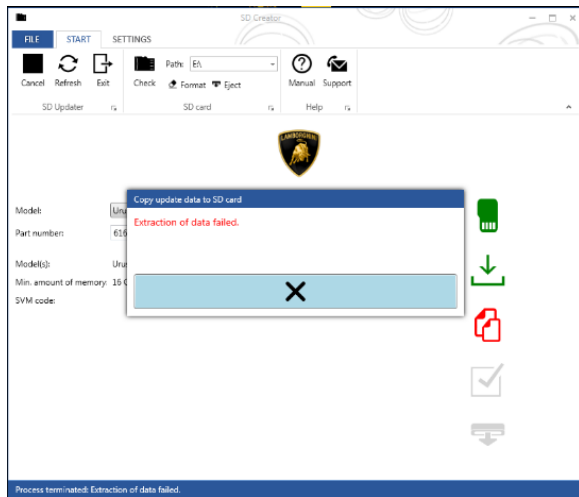
If the following error should occur, it is necessary to follow the instructions given in BI.25.18 (Rev.02), which can be downloaded on the Lamborghini HUB portal:
