Technical Service Bulletin (TSB)
RSU With Additional Sleep Cycles for HV Battery Integrity Check
- Flash: Battery Pack Control Module (BPCM) Updates 11A1

REFERENCE:	TSB: 08-076-25 REV. A GROUP: 08 - Electrical	Date:	April 25, 2025	REVISION:	08-076-25
VEHICLES AFFECTED:	2024 (KM) Jeep Wagoneer S This bulletin applies to vehicles equipped with 400V G2500 FR/RR Elec Drive Motors (Sales Code ELD).			MARKET APPLICABILITY: <input checked="" type="checkbox"/> NA <input checked="" type="checkbox"/> **IAP** <input checked="" type="checkbox"/> **SA** <input checked="" type="checkbox"/> **CH** <input checked="" type="checkbox"/> **EE** <input checked="" type="checkbox"/> **MEA** **	
CUSTOMER SYMPTOM:	<p>Customers may experience a Malfunction Indicator Lamp (MIL) illumination and the vehicle may exhibit/set one or more of the following Diagnostic Trouble Codes (DTCs):</p> <ul style="list-style-type: none"> ● **P0DE6 - Hybrid/EV Battery Pack Cell Voltage Low. <p>NOTE: Active or stored.</p> <ul style="list-style-type: none"> ● P1DAF - Incompatible Limp In Action Requested. <p>NOTE: Active or stored.</p> <ul style="list-style-type: none"> ● P1CDE – Hybrid/EV Wakeup Control 2 Output Circuit Short

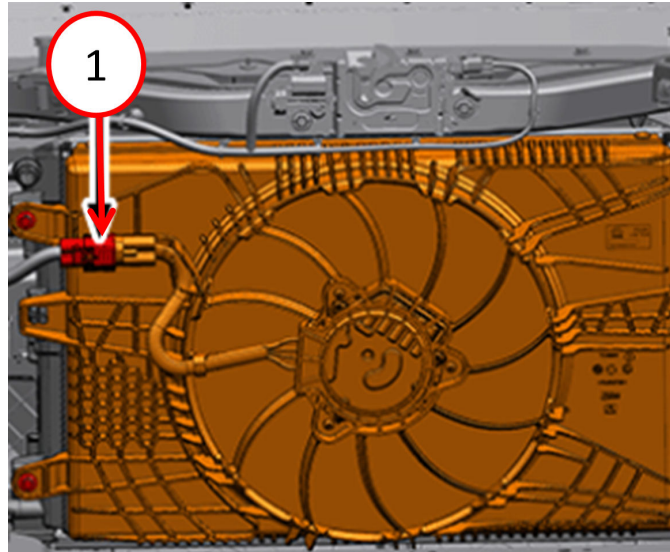
Fig. 1
Cooling Fan Assembly

NOTE: The cooling fan must be disconnected to prevent it from powering on, which may interrupt/ abort the flash process.
4. Disconnect the cooling fan wire harness connector [Fig. 1](#).

1 - Wire Harness To Disconnect/Connect

26. Connect the cooling fan wire harness connector [Fig. 1](#).

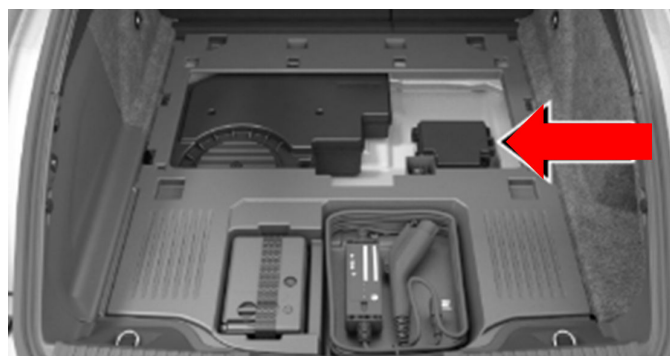
Fig. 2
Rear PDC Location

5. From the rear of the vehicle, pull back the carpet to access the rear Power Distribution Center (PDC) [Fig. 2](#).

24. **Install the #38 AGSM fuse [Fig. 3](#) and the PDC cover [Fig. 2](#).

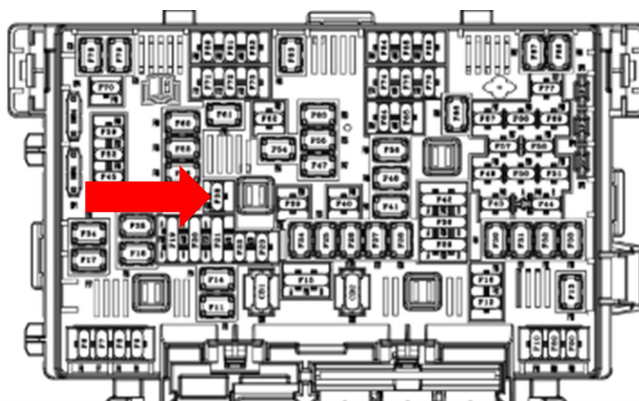
Fig. 3
#38 AGSM Fuse Location

Failure to remove the #38 AGSM fuse will result in damage to the shifter.

6. Remove the PDC cover, locate and remove the #38 AGSM fuse [Fig. 3](#).**
