Technical Service Bulletin (TSB)
Multiple Systems Repair Bundle Campaign

REFERENCE:	TSB: 23-019-25 REV. A GROUP: 23 - Body	Date:	April 26, 2025	REVISION:	23-019-25
VEHICLES AFFECTED:	**2024** - 2025 (JL) Jeep Wrangler This bulletin applies to vehicles built on or after July 01, 2024 (MDH 0701XX) and on or before February 28, 2025 (MDH 0228XX).			MARKET APPLICABILITY: <div><input type="checkbox"/> NA<input type="checkbox"/> MEA</div> <div><input type="checkbox"/> SA<input checked="" type="checkbox"/> IAP</div> <div><input type="checkbox"/> EE<input type="checkbox"/> CH</div>	
CUSTOMER SYMPTOM:	<p>Customers must experience a Malfunction Indicator Lamp (MIL) illumination and the vehicle must exhibit/set one or more of the following Diagnostic Trouble Codes (DTCs):</p> <ul style="list-style-type: none">• P0133 - O2 Sensor 1/1 Slow Response.• P2251 - O2 Sensor 1/1 Negative Current Control Circuit/Open.• P0131 - O2 Sensor 1/1 Circuit Low.• P2626 - O2 Sensor 1/1 Pump Cell Current Trim Circuit/Open.• P0607 - ECU Internal Performance.• C140A - Transfer Case Motor Control.• P02EE - Cylinder 1 injector Circuit Performance.• P02EF - Cylinder 2 injector Circuit Performance.• P02F0 - Cylinder 3

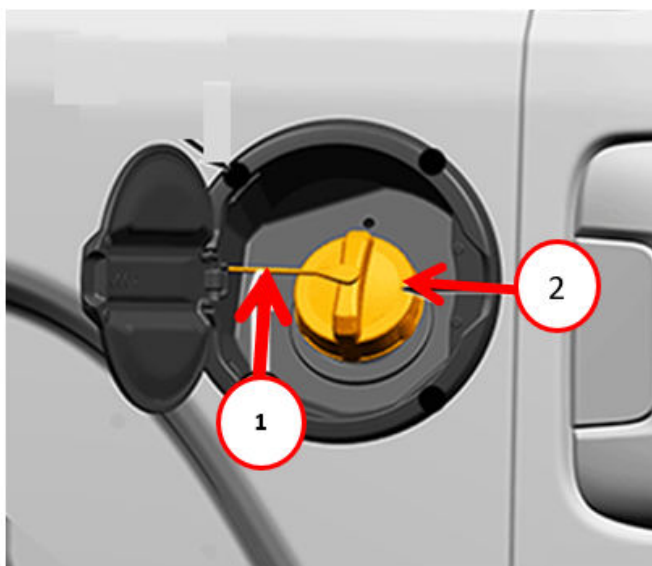
Fig. 1
Fuel Cap Replacement

13. Is the fuel cap tether strap broken?

14. Remove the fuel cap tether strap fastener securing the strap to the fuel door housing [Fig. 1](#).

15. Replace the fuel cap tether strap and the fuel cap assembly.
