Technical Service Bulletin (TSB)

Fuel Injector Leak

REFERENCE:	TSB: 14-009-25 REV. A GROUP: 14 - Fuel System	Date:	April 26, 2025	REVISION:	14-009-25
VEHICLES AFFECTED:	2022 - 2024 (B1) Jeep Renegade 2022 - 2024 (H1) Jeep Commander 2022 - 2024 (M1) Jeep Compass This bulletin applies to the vehicle built on or before March 12, 2024 (MDH 0312XX) equipped with a **1.3L I4 Turbo MAIR DI Engine w/ESS E100 (Sales Code EYJ)**.			MARKET APPLICABILITY: <div><input type="checkbox"/> NA<input type="checkbox"/> MEA</div> <div><input checked="" type="checkbox"/> SA<input type="checkbox"/> IAP</div> <div><input type="checkbox"/> EE<input type="checkbox"/> CH</div>	
CUSTOMER SYMPTOM:	Customers must experience a Malfunction Indicator Lamp (MIL) illumination and the vehicle must exhibit/set one or more of the following Diagnostic Trouble Codes (DTCs): <ul style="list-style-type: none">• P0087-00 - Fuel Line Pressure Sensor - Bank 1 - Pressure Below Limit.• P0300-00 - Multiple Cylinder Misfire.• P0301 - Cylinder 1 Misfire.• P0302 - Cylinder 2 Misfire.• P0303 - Cylinder 3 Misfire.• P0304 - Cylinder 4 Misfire.• P006C-00 - Air Pressure and Temperature Sensor - Correlation. Customers may also comment

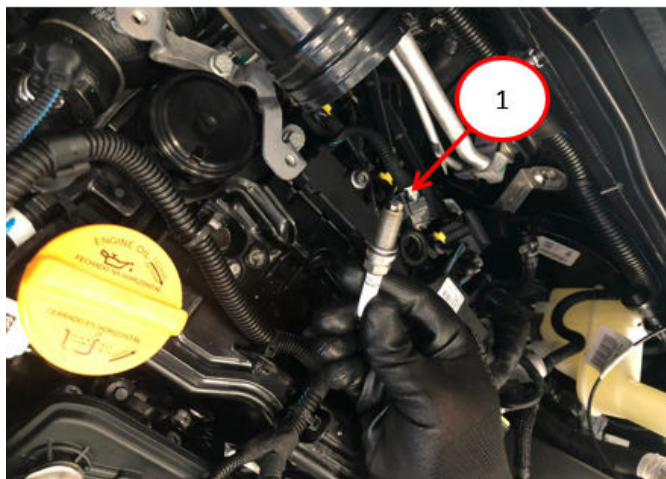
Fig. 1
Spark Plugs

1. Remove the spark plugs [Fig. 1](#). Refer to the detailed service procedures available in DealerCONNECT/ Service Library under: Service Info> 5510D10 – Velas de ignição – Remoção e Recolocação.

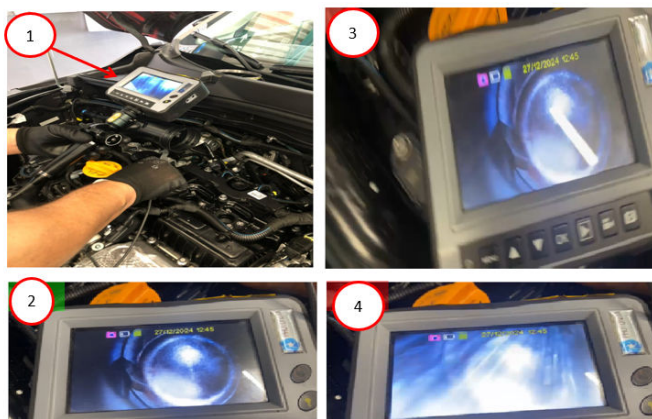
Fig. 2
Endoscope Inspection Screens

2. Using an Endoscope, check all the injectors [Fig. 2](#). With the help of a collaborator, ask him/her to cycle the ignition without starting the vehicle. **Keep the ignition on for one minute per injector.**

- 1 - Endoscope
- 2 - Injector Inspection Okay
- 3 - Injector Inspection Not Okay
- 4 - Injector Inspection Not Okay

1. Replace all fuel injectors and the high pressure tube. Refer to the detailed service procedures available in DealerCONNECT/Service Library under: Service Info> 1056F60 - Turbo Coletor de Combustível Único - Completo de Eletroinjeter Remoção/Recolocação.
2. Clear DTCs.
