| <b>Title:</b> | <b>PACCAR Dipstick Routing</b> | | | |
| <b>Number:</b> | <b>SB_741</b> | <b>Release Date:</b> | <b>04/29/2025</b> | |
| <b>Chassis Type:</b> | <b>Custom chassis equipped w/ PACCAR engine</b> | | | |
| <b>Component Description:</b> | <b>PACCAR Engine Dipstick</b> | | | |

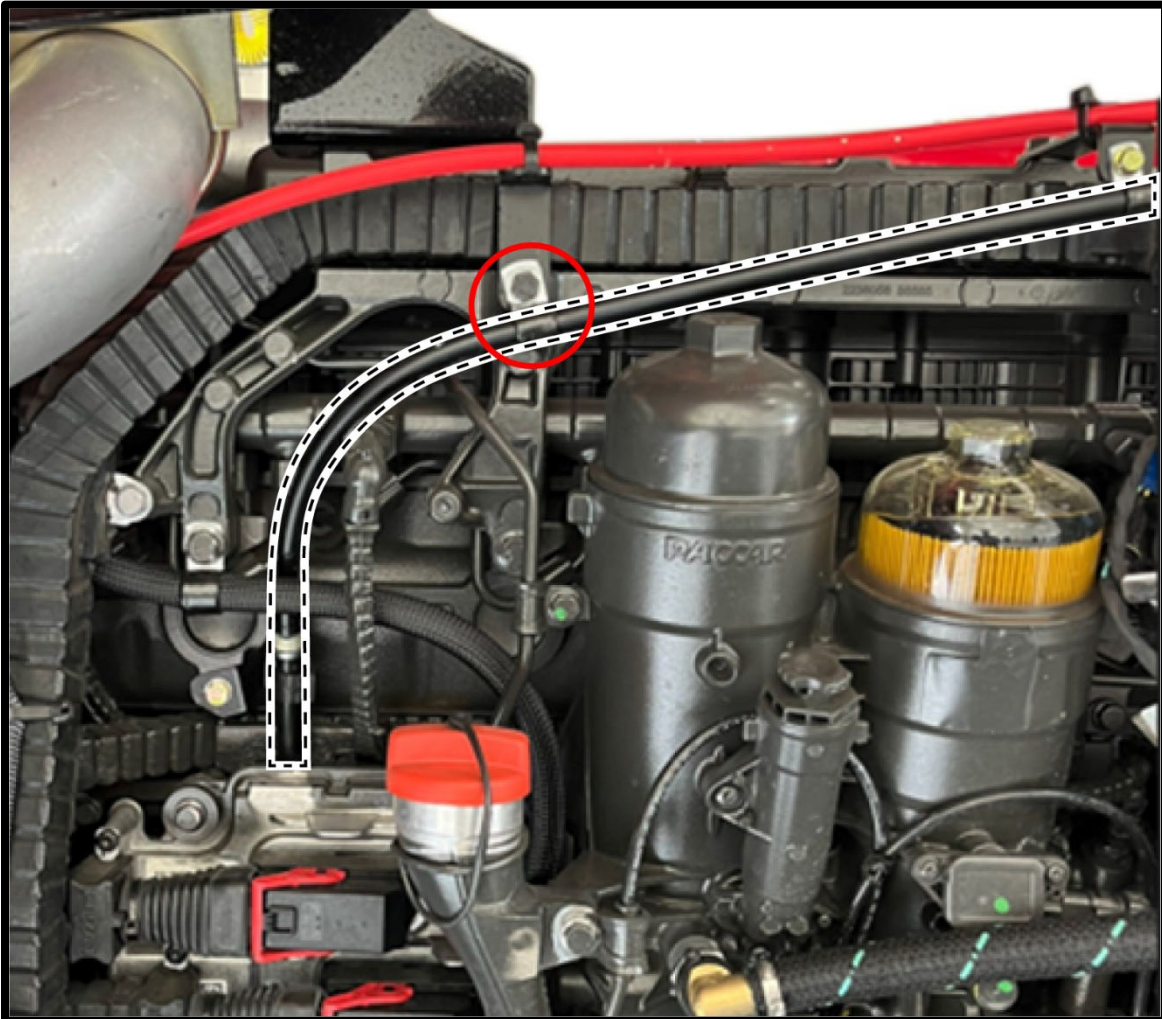
There have been reports of several dipsticks on PACCAR engines getting caught while attempting to check the oil level due to incorrect routing. This bulletin will cover the corrective procedure to prevent the dipsticks from getting caught. A production change has been made to address this during the build process.

***Incorrect Routing***

The corrective action for this is to inspect and repair the bend in the tube, if required. This can be accomplished by removing the first P-clamp on the engine and flipping it around.

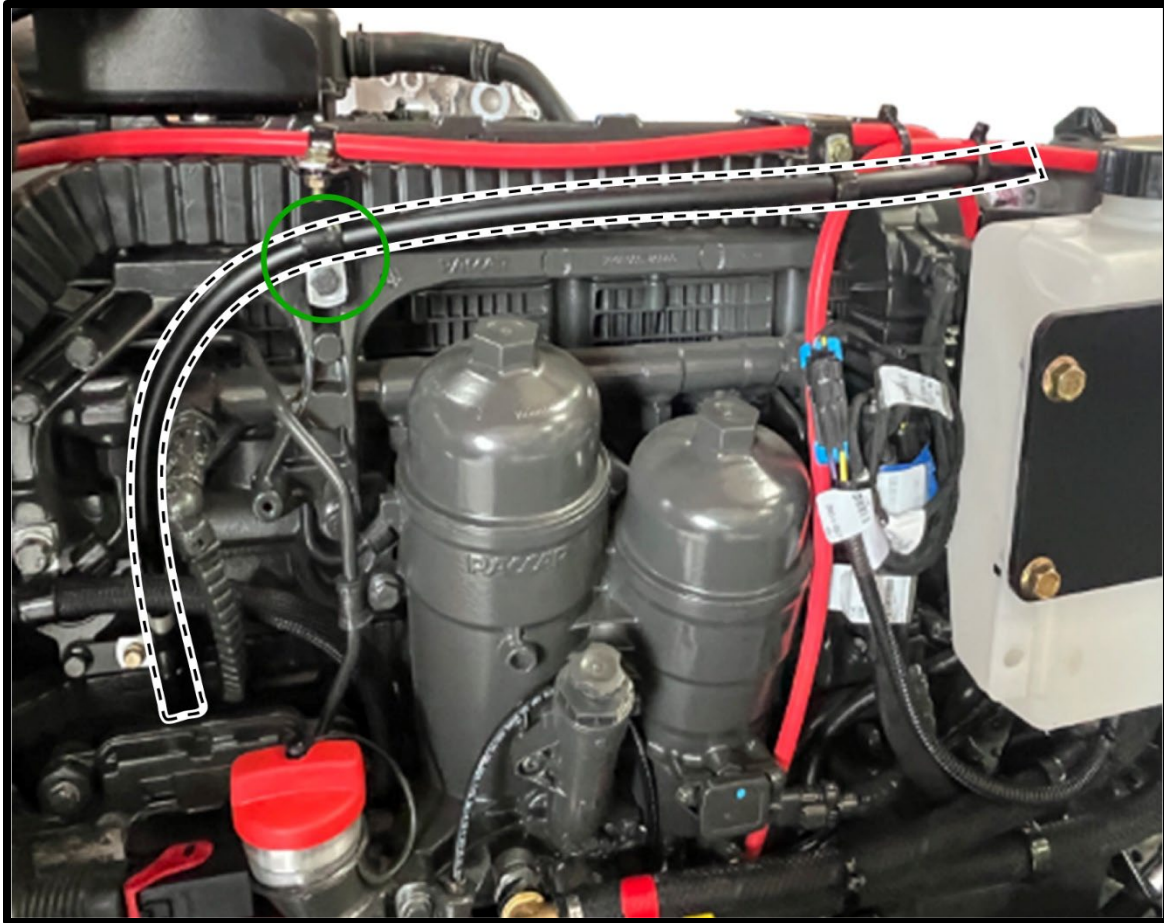
*Correct Routing*
