Technical Service Bulletin (TSB)
R1H Radio Over The Air Update U35.26
and U35.34 To U37.23 Software Version

REFERENCE:	TSB: 08-147-25 GROUP: 08 - Electrical	Date:	May 8, 2025	REVISION:	—
VEHICLES AFFECTED:	2024 - 2025 (KM) Wagoneer S This bulletin applies to vehicles built on or before May 09, 2025 (MDH 0509XX) equipped with a Global Telematics Box Module (Sales Code RDG) and one of the following radios: <ul style="list-style-type: none"> • Uconnect 5 Nav W 12.3" Display (USA) (Sales Code UBX). • Uconnect 5 Nav W 12.3" Display (CAN) (Sales Code UEX). 			MARKET APPLICABILITY:	
				<input checked="" type="checkbox"/> NA	<input type="checkbox"/> MEA
				<input type="checkbox"/> SA	<input type="checkbox"/> IAP
				<input type="checkbox"/> EE	<input type="checkbox"/> CH
CUSTOMER SYMPTOM:	Customers may experience one or more of the following: <ul style="list-style-type: none"> • Pop-up messages text cut-off "Transfer to Passenger". • Missing active call details in phone widget after swap is performed. • Missing Pop-up messages for Blind Spot related to Lane Management on/off. • Virtual wall option in menu present (should be removed). • Customer need to select Sound type in EV pages twic

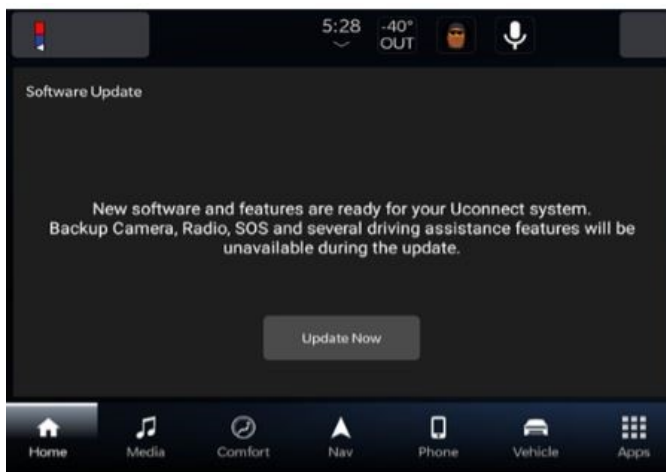
Fig. 1
Software Update Screen

2. If the customer selects “Update Now” they can shut off the vehicle and leave. The update will be completed automatically [Fig. 1](#).

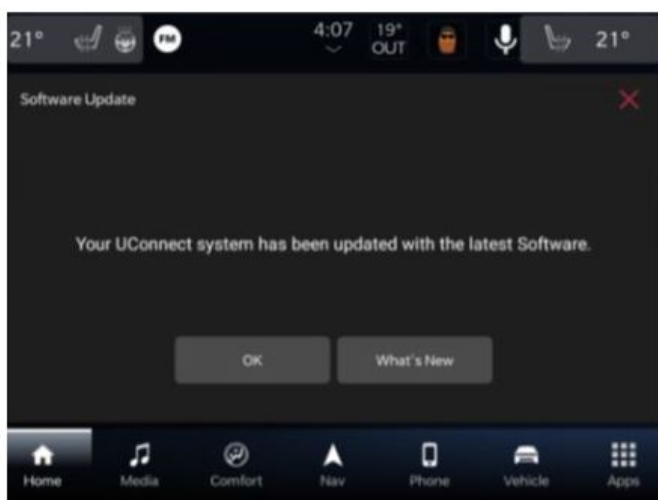
Fig. 2
Software Update Confirmation Screen

3. Upon completion of update, the radio will display a confirmation message [Fig. 2](#).
