**Technical Service Bulletin (TSB)**  
**Radio U37.23 USB Software Update**

<b>REFERENCE:</b>	<b>TSB:</b> 08-152-25 <b>GROUP:</b> 08 - Electrical	<b>Date:</b>	May 9, 2025	<b>REVISION:</b>	-
<b>VEHICLES AFFECTED:</b>	<b>2024 - 2025 (KM) Jeep Wagoneer S</b> <b>This bulletin applies to vehicles built on or before May 09, 2025 (MDH 0509XX) equipped with one of the following radios:</b> <ul style="list-style-type: none"> <li>Uconnect 5 Nav W 12.3" Display (USA) (Sales Code UBX).</li> <li>Uconnect 5 Nav W 12.3" Display (CAN) (Sales Code UEX).</li> <li>Uconnect 5 Nav W 12.3" Display (MEX) (Sales Code UFX).</li> </ul>			<b>MARKET APPLICABILITY:</b>	
				<input checked="" type="checkbox"/> NA	<input type="checkbox"/> MEA
				<input type="checkbox"/> SA	<input type="checkbox"/> IAP
				<input type="checkbox"/> EE	<input type="checkbox"/> CH
<b>CUSTOMER SYMPTOM:</b>	<b>Customers may experience one or more of the following:</b> <ul style="list-style-type: none"> <li>Pop-up messages text cut-off "Transfer to Passenger".</li> <li>Missing active call details in phone widget after swap is performed.</li> <li>Missing Pop-up messages for Blind Spot System (BSS) related to Active Lane Management (AL

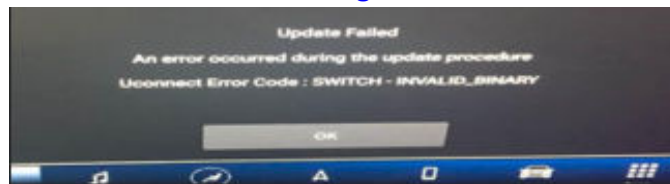
**Fig. 4**  
Switch-Invalid\_Binary Error

**NOTE:** Sometimes the radio throws an error pop up "Switch-Invalid\_Binary" after successful radio update. Please ignore this error and click ok [Fig. 4](#).
