STAR ONLINE PUBLICATION

Case Number: S2523000047

Release Date: May 2025

Symptom/Vehicle Issue: Squeak Buzz Rattle (BSR) From The Headliner Near The Grab Handle Or B-Pillar With MKS Full Glass Roof.

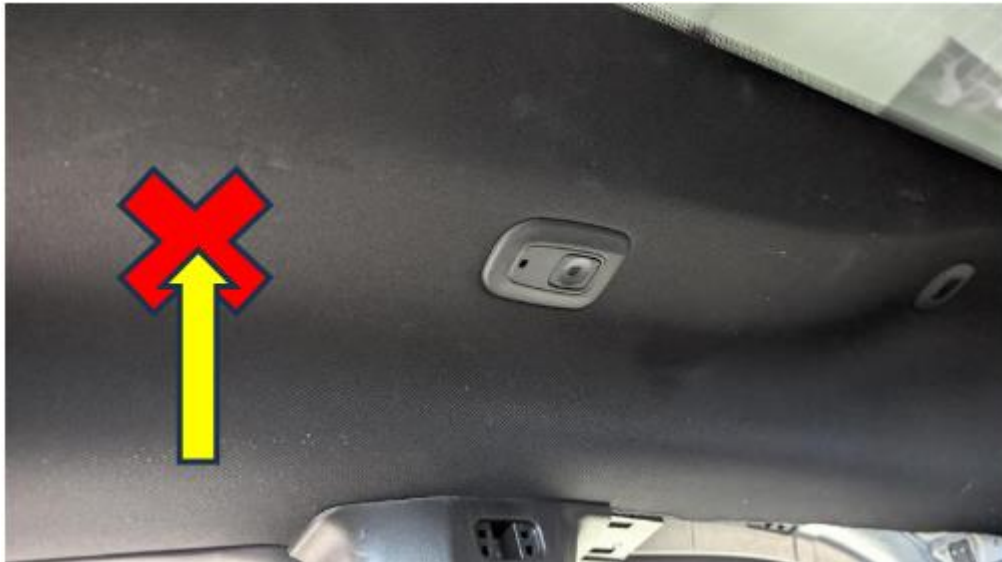
Fig 1.

Discussion: Drive vehicle on rough road or twisty roads. With an assistant driving and noise duplicating, press upwards in between the grab handle and push lamp headliner (Fig1). If the noise is diminished or removed while pressing up continue with the below procedure to add a BSR tape such as MOPAR Flock Tape 68230057AB.

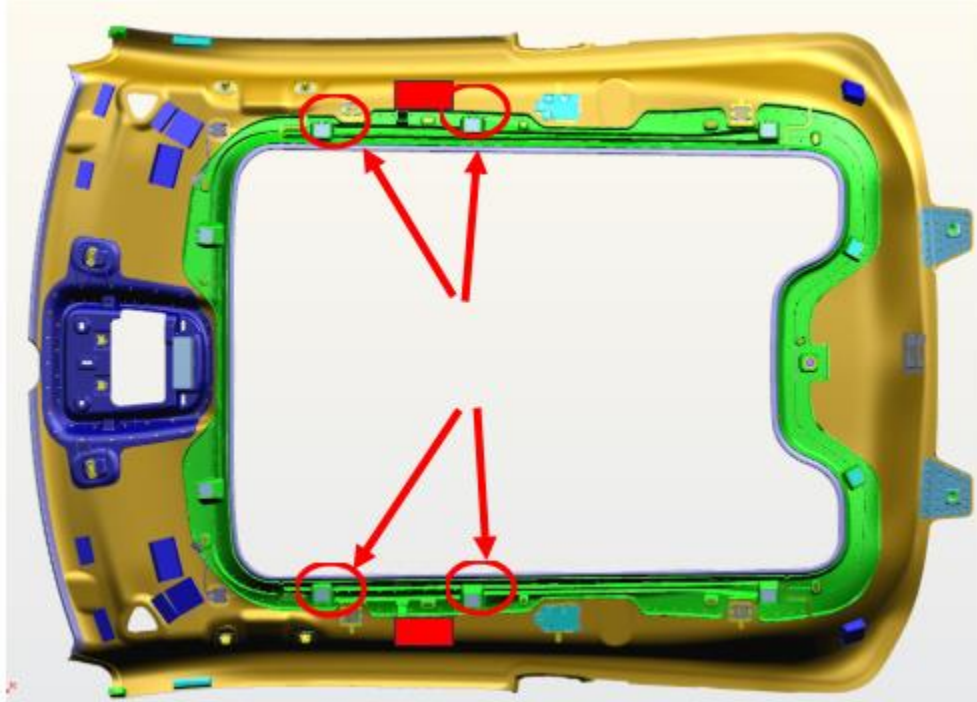
Fig 2.
Velcro Location.

1. Disengage the hook and loop fastener tape in the 2 spots shown below on whichever side has the problem. They are located next to the push lamp and the grab handle around the glass roof opening.

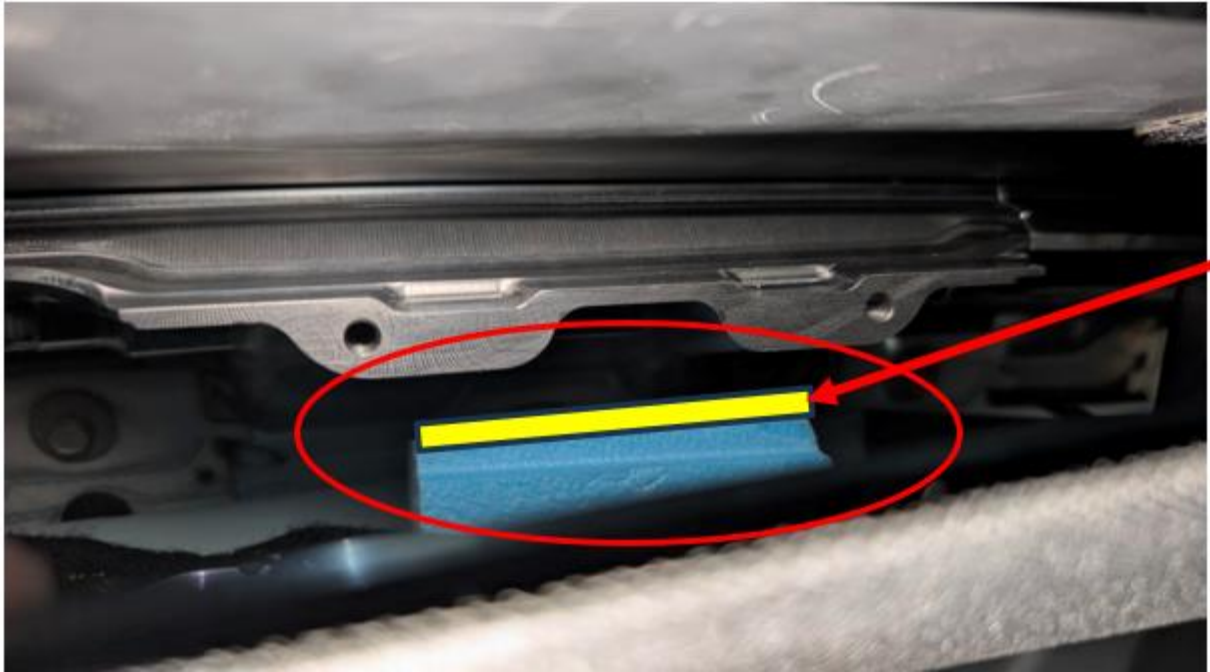
Fig 3.
Flock Tape Added To Top Of Blue Block.

2. Carefully pull down the headliner from the glass roof opening enough to access the blue block. Add felt tape on top of the blue block to completely cover the surface of the block (Fig 3).

3. Once felt tape is installed, re-engage the headliner hook and loop fastener tape by pressing the headliner up by hand. Test drive to verify repair.
