## ENGINE OIL COOLER PIPE LEAK – 4.4L NC11

SSM 76308

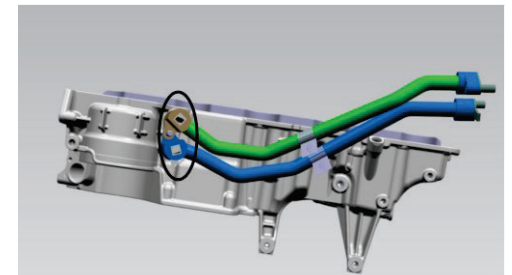
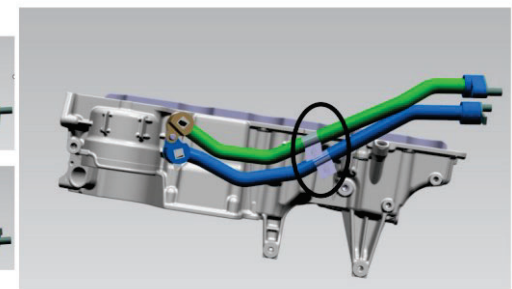
- Engine oil cooler feed and/or return pipe leaking engine oil from the oil pan extension oil cooler port(s).
- Pinched, split or deformed O-ring.

- Confirm oil leak is at the engine cooler line at the oil pan extension.
- Take clear photographs to attach to EPQR of:
  - Two oil cooler bores in the oil pan
  - Affected O-rings for any damage (do not remove them from pipe).
  - Picture of the serial number label of pipe (see lower picture)
  - Once repairs are complete, please attach all documentation to an EPQR and reference SSM76308.
- Please keep all parts for Parts return request.
