**RECREATIONAL VEHICLE SERVICE CAMPAIGN**

**SERVICE ADVISORY 25-467**

### Aspen Trail Dinette Back

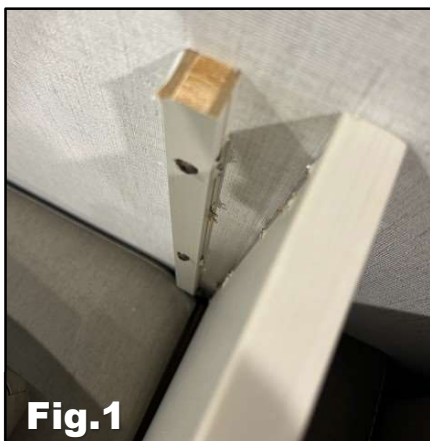
It has been determined there is inadequate support for the dinette back. The following procedure describes how to identify and secure the dinette backs.

Remove cleat from dinette back using putty knife or scraper tool to gently pry, use screw gun remove screws and discard cleat. **Figure 1** shows cleat installed.

The remedy: Remove cleat from dinette back, install six L-Brackets with 5/8 “wood screws to seat back.
