New Message Code LH8

MY 2023 - 2024 Jeep Grand Cherokee (WL) - Removal of the Engine Cover on 3.6L Engines

MY 2025 RAM 1500 Pickup (DT), Jeep Wrangler (JL), Jeep Gladiator (JT) - Security Gateway (SGW) Module Sets Diagnostic Trouble Code (DTC) U0080-00 Ethernet BUS 1

MY 2025 ProMaster (VF) - 12 Volt Battery

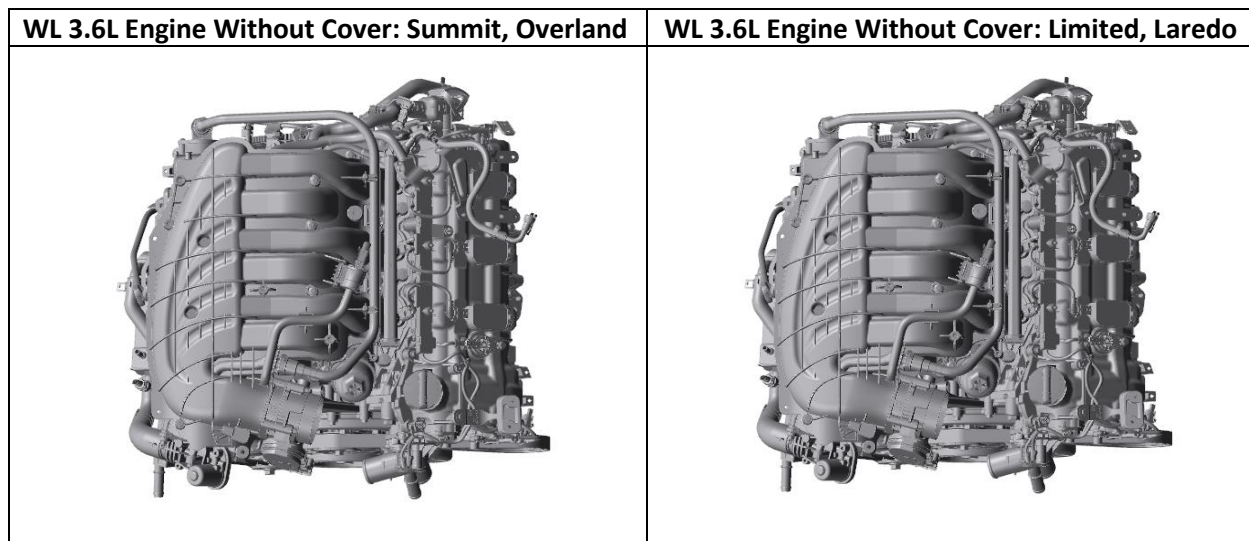
Summit and Overland trim grades has been in effect since January 17th, 2024. WL with the 3.6L engine, the engine cover **DOES NOT** apply to the **Summit, Overland, Laredo, and Limited** trim grades. The engine covers have been removed from these vehicles. Please note that this notice is **NOT** applicable to the other engine variants, which currently receive an engine cover.

Figure 1: Overhead view of the WL 3.6L Engine without the engine cover

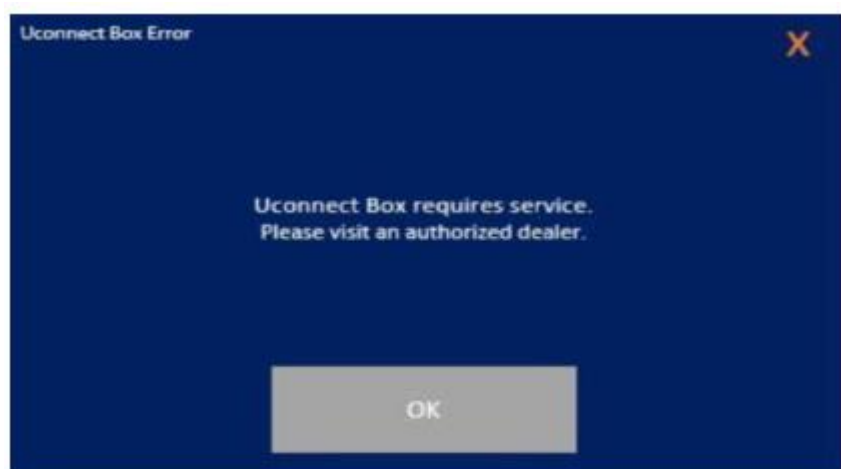
Pg 1

The technician observed the SGW setting DTC U0080-00 as stored.

Use scan tool select >guided diagnostics>reset ECU >TBM. Inspect the Telematics Box Module (TBM) connections.

1. Remove upper and lower glove box to access the TBM module pg. 2.
2. Inspect the connector(s) at the TBM module.
3. Use the Push-Pull-Push method to secure the connections.
4. Clear Diagnostic Trouble Codes (DTCs).
5. Test the operation to complete no parts required.

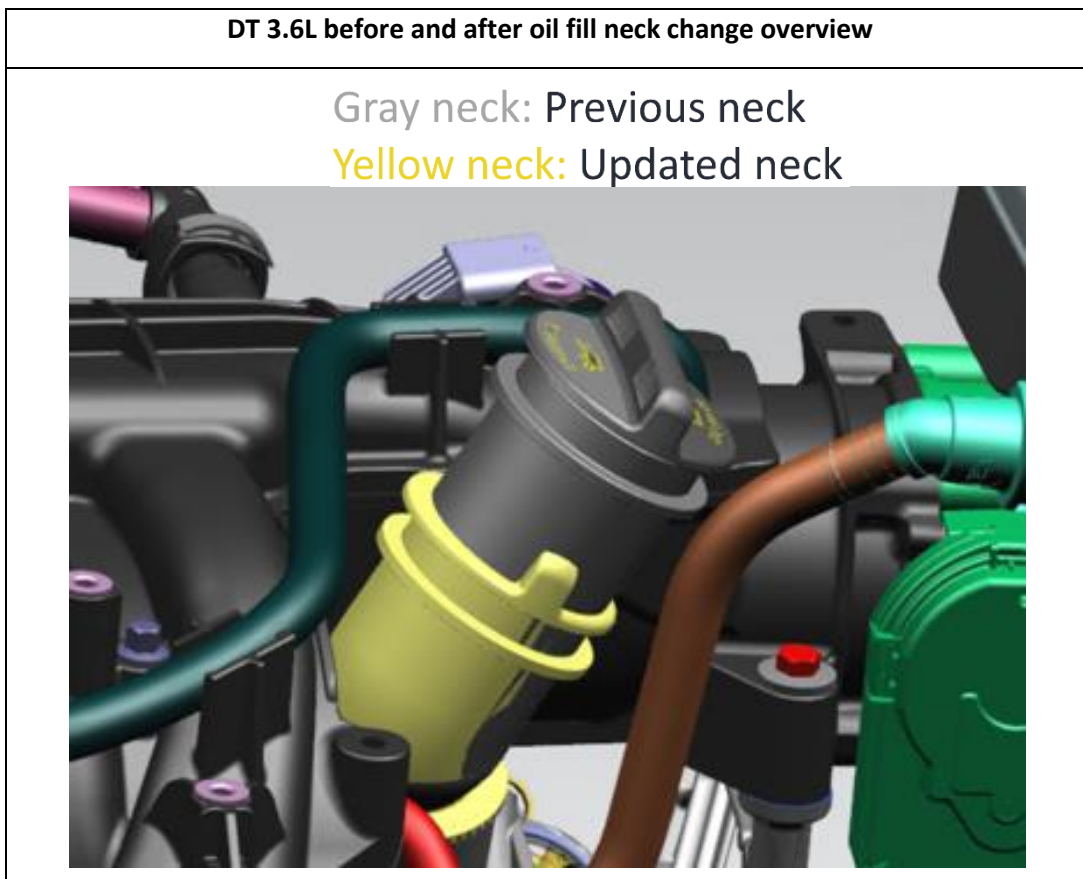
The change of implementing the JL/JT oil fill neck into DT family will take place beginning with Engine Build dates from 06/16. The intention is to make you aware of this change.

Figure 1: Visual reference of before and after

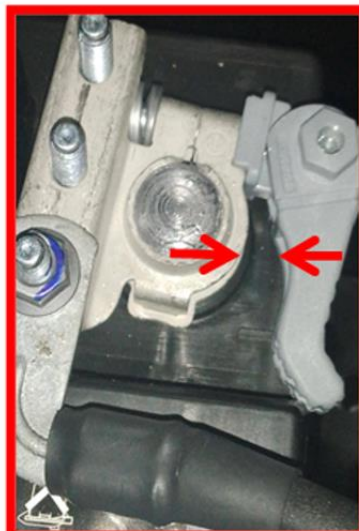
Picture of Defect

- 12-Volt Battery Negative Post Clamp not closed, with contact with the plastic

battery casing.

- Negative post clamp position not fully down.

Negative post clamp position not fully closed.

Not Fully down.

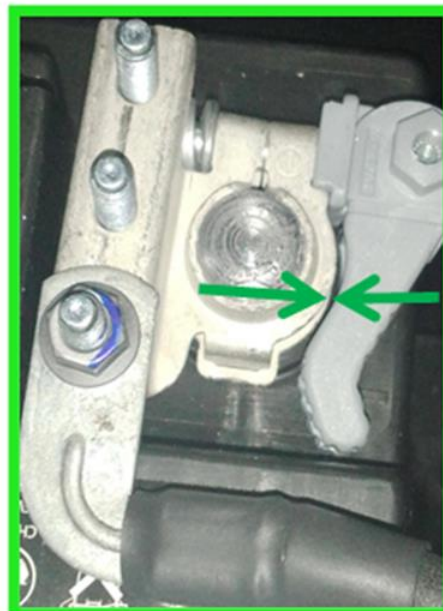
Picture of Good connection

- Fully closed 12-Volt battery negative post clamp, no contact with the plastic battery casing.
- Negative post clamp position fully down.

Negative post clamp position fully closed.

Fully down.
