## MY 2023 - 2024 - Jeep Grand Cherokee (WL) - Removal of the Engine Cover on 3.6L Engines

## MY 2025 RAM 1500 Pickup (DT), Jeep Wrangler (JL), Jeep Gladiator (JT) - Security Gateway (SGW) Module Sets Diagnostic Trouble Code (DTC) U0080-00 Ethernet BUS 1

## MY 2025 RAM 1500 Pickup (DT) – Commonization of Carryover Jeep Wrangler (JL)/Jeep Gladiator (JT) Oil Fill Neck Into DT on 3.6L Engines

## MY 2025 ProMaster (VF) - 12 Volt Battery

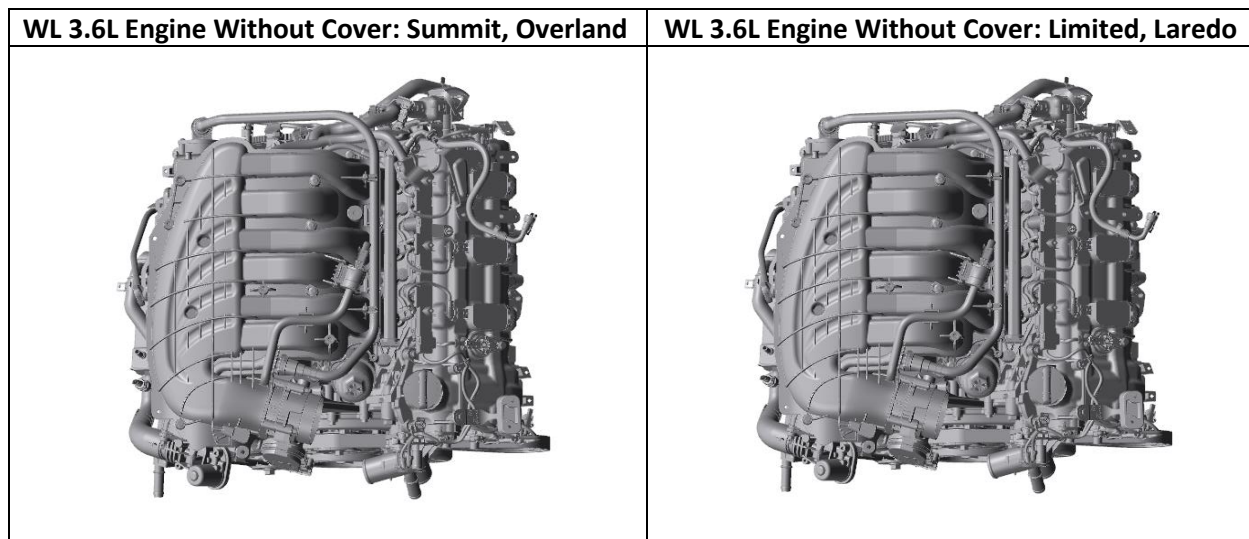
Figure 1: Overhead view of the WL 3.6L Engine without the engine cover

Summit and Overland trim grades has been in effect since January 17th, 2024. WL with the 3.6L engine, the engine cover **DOES NOT** apply to the **Summit, Overland, Laredo, and Limited** trim grades. The engine covers have been removed from these vehicles. Please note that this notice is **NOT** applicable to the other engine variants, which currently receive an engine cover.

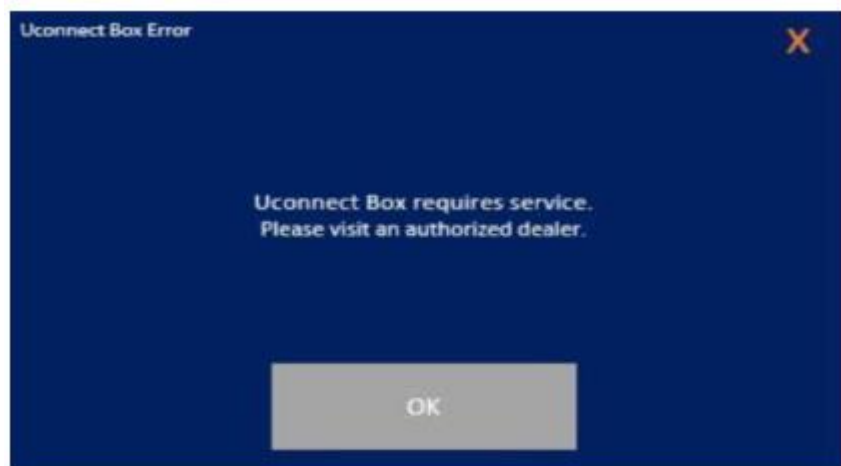
The technician observed the SGW setting DTC U0080-00 as stored.

Use scan tool select >guided diagnostics>reset ECU >TBM. Inspect the Telematics Box Module (TBM) connections.

1. Remove upper and lower glove box to access the TBM module pg. 2.
2. Inspect the connector(s) at the TBM module.
3. Use the Push-Pull-Push method to secure the connections.
4. Clear Diagnostic Trouble Codes (DTCs).
5. Test the operation to complete no parts required.

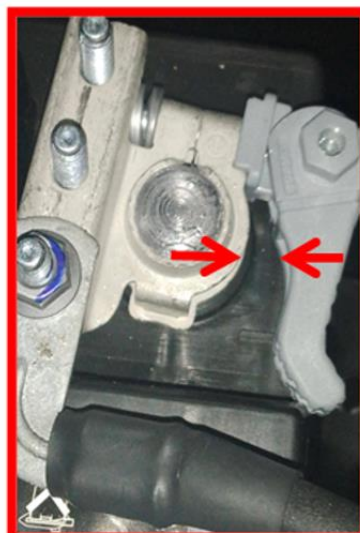
### Picture of Defect

- 12-Volt Battery Negative Post Clamp not closed, with contact with the plastic

battery casing.

- Negative post clamp position not fully down.

Negative post clamp position not fully closed.

Not Fully down.

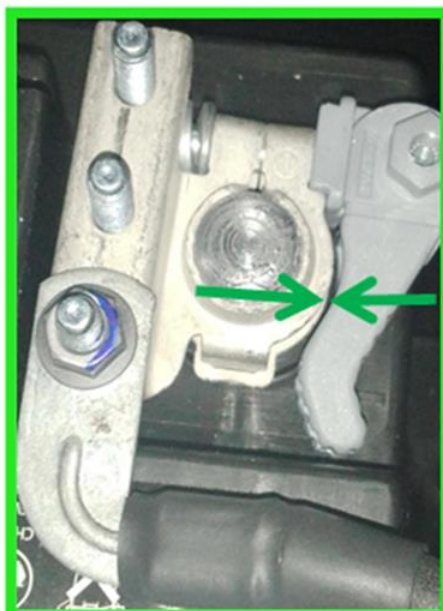
### Picture of Good connection

- Fully closed 12-Volt battery negative post clamp, no contact with the plastic battery casing.
- Negative post clamp position fully down.

Negative post clamp position fully closed.

Fully down.
