REFERENCE:	TSB: 05-001-25 GROUP: 05 - Brakes	Date:	May 17, 2025	REVISION:	-
VEHICLES AFFECTED:	2024 - 2025 (VF) RAM Promaster This bulletin applies to vehicles built on or before April 15, 2025 (MDH 0415XX) equipped with a 3.6L V6 24V VVT Engine (Sales Code ERF).			MARKET APPLICABILITY:	
				<input checked="" type="checkbox"/> NA	<input type="checkbox"/> MEA
				<input type="checkbox"/> SA	<input type="checkbox"/> IAP
				<input type="checkbox"/> EE	<input type="checkbox"/> CH
CUSTOMER SYMPTOM:	Customers may comment on one or more of the following:				
	<ul style="list-style-type: none"> • Brake pedal travel is longer than expected to stop the vehicle. • Have to really press on the brake pedal to get the vehicle to stop. 				
CAUSE:	Over torqued brake fluid reservoir cap

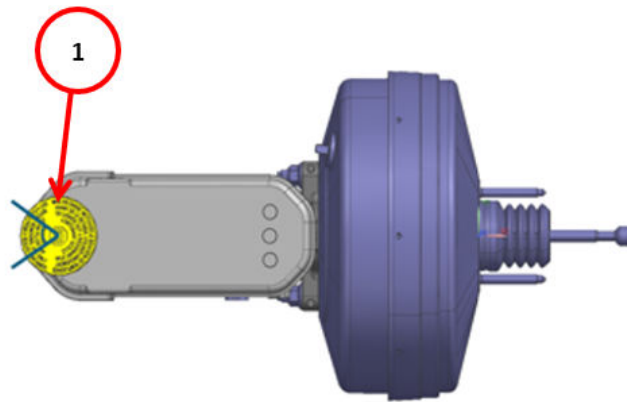
Fig. 1
Brake Fluid Reservoir Cap

1 - Correctly Orientated Brake Fluid Reservoir Cap

1. Remove the brake fluid reservoir cap.
2. Perform the brake bleed procedure. Refer to the detailed service procedures available in DealerCONNECT/Service Library under: Service Info> 05 - Brakes / Standard Procedure / Brake Bleeding Procedure.
3. Install the brake fluid cap by turning it until you feel slight resistance, then gently tighten the cap to ensure it is secure.

Ensure that the brake fluid reservoir cap is pointing out from the reservoir to prevent over tightening **Fig. 1**.
