REFERENCE:	TSB: 08-160-25 GROUP: 08 - Electrical	Date:	May 17, 2025	REVISION:	-
VEHICLES AFFECTED:	2025 (DT) RAM 1500 Pickup This bulletin applies to vehicles built on or after June 20, 2024 (MDH 0620XX) equipped with one of the following radios: <ul style="list-style-type: none"> Uconnect 5 Nav W 12.0" Disp (ROW-DAB) (Sales Code UPQ). Uconnect 5 NAV W 14.4" Disp (ROW-DAB) (Sales Code UPW). 	MARKET APPLICABILITY:			
		<input type="checkbox"/> NA		<input checked="" type="checkbox"/> MEA	
		<input type="checkbox"/> SA		<input type="checkbox"/> IAP	
		<input type="checkbox"/> EE		<input type="checkbox"/> CH	
CUSTOMER SYMPTOM:	Customers may comment on the following: <ul style="list-style-type: none"> The vehicle has North American maps installed instead of the International maps. 				
CAUSE:	Incorrect software

This bulletin involves inspecting the navigation map region and possibly installing International maps to the radio via USB.

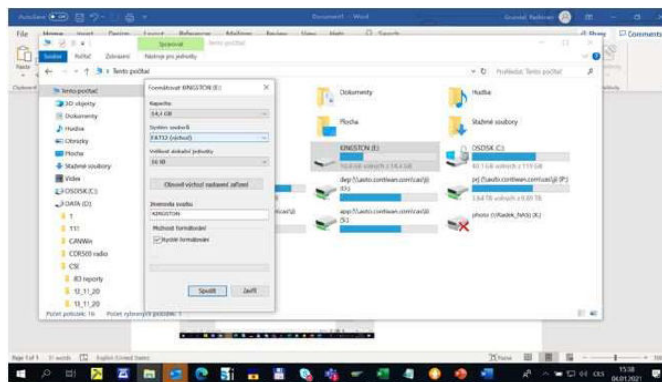
Fig. 1
USB Flash Drive Formatted

5. Select "JEEP".
6. Select "Grand Cherokee"
7. Select "Uconnect 5 Nav".
8. Select "SEARCH FOR UPDATES".
9. Select the "Download" button.
10. Download the software map file onto a USB. To download the software files to a USB flash drive, follow the onscreen instructions and perform the following [Fig. 1](#):

- Blank USB flash drive needs to be formatted as NTFS.
 - Acquire a blank USB flash drive with at least 64 GB of space.
 - Download the software update file to your local PC's desktop.
