Service Bulletin

Bulletin No.: PIC6608

Subject: Flutter - Rattle Noise from High Bass Audio Input on Front Door Trim Panel

Brand:	Model:	Model Year:		VIN:		Engine:	Transmission:
		from	to	from	to		
Cadillac	OPTIQ	2025		SOP	April 17th, 2025	All	All

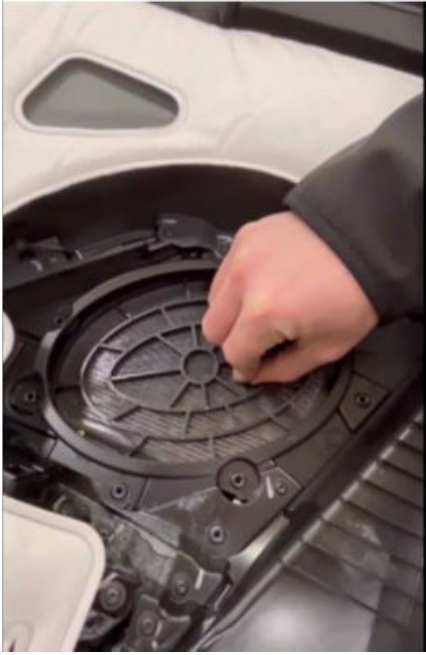
6932121

From back side of the door panel, the tech will be able to locate a scrim material between the metal grill and a plastic frame.
