Service Bulletin

Bulletin No.: PIP6065

Subject: Service All Wheel Drive Message C1267

Brand:	Model:	Model Year:		VIN:		Engine:	Transmission:
		from	to	from	to		
Cadillac	XT6	2025		ALL	ALL	ALL	ALL

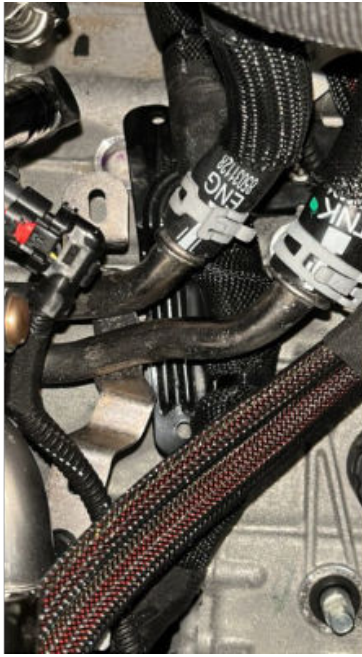
6932045

Inspect the wiring harness between connector X112 and the M115 PTU Shift Actuator.

It may be found that some of the "Christmas tree" retainers are missing and the harness has been rubbing on the transmission case.

If this concern is found, repair the damaged circuits as necessary, and properly retain the harness so that future damage will be avoided.
