REFERENCE:	TSB: 23-023-25 GROUP: 23 - Body	Date:	May 17, 2025	REVISION:	—
VEHICLES AFFECTED:	2024 - 2025 (RU) Chrysler Pacifica This bulletin applies to vehicles built on or after February 01, 2024 (MDH 0201XX) and on or before February 14, 2025 (MDH 0214XX).			MARKET APPLICABILITY:	
				<input checked="" type="checkbox"/> NA	<input type="checkbox"/> MEA
				<input type="checkbox"/> SA	<input type="checkbox"/> IAP
				<input type="checkbox"/> EE	<input type="checkbox"/> CH
CUSTOMER SYMPTOM:	Customers may experience one or more of the following:				
	<ul style="list-style-type: none"> • The rear carpet is untucked. • The rear carpet is torn. • The rear carpet is coming out/loose. 				
CAUSE:	Manufacturing issue

This bulletin involves modifying the rear tub carpet fasteners.

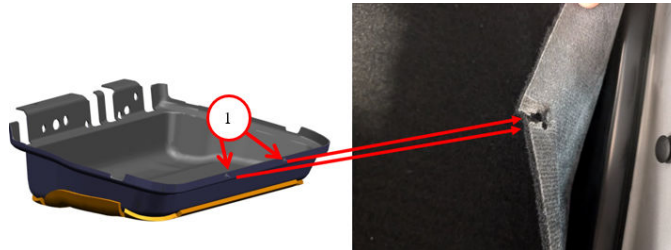
Fig. 1
Remove Tube Fasteners

1 - Tub Fasteners

1. Remove the rear liftgate sill scuff plate. Refer to the detailed service procedures available in DealerCONNECT/Service Library under: Service Info> 23 - Body / Interior / Plate, Scuff, Liftgate Sill / Removal.
2. Remove the two fasteners securing the carpet to the tub Fig. 1.

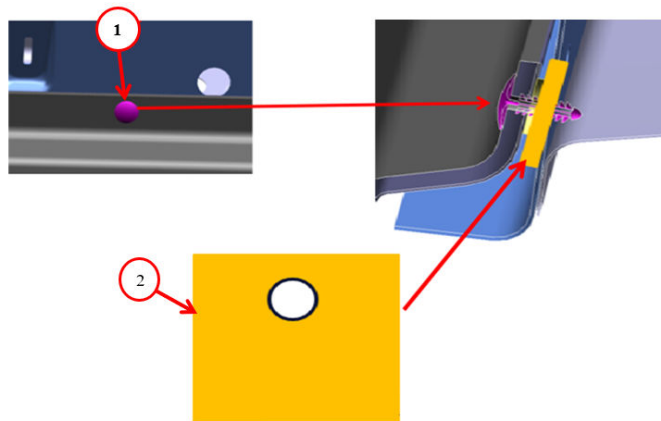
Fig. 2
Fastener With Tape Installation

1 - Tub Fastener
2 - Felt Tape With Hole

3. Install the fasteners including one piece of 38 mm. x 38 mm. (1.5 in. x 1.5 in.) felt tape per fastener Fig. 2.
