# Service Bulletin

Bulletin No.: PIT6379

**Subject: Radio Stability Issues After Carplay Use**

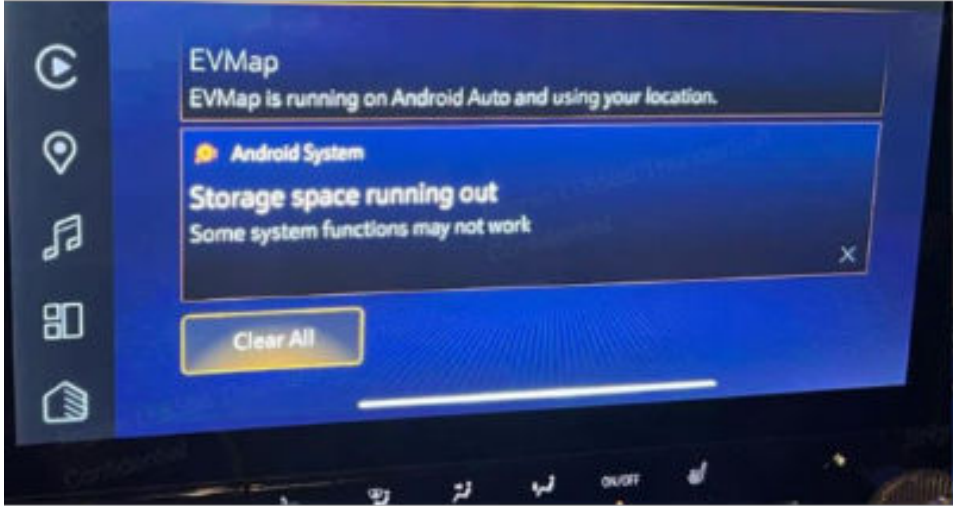
<p style="text-align: right;">6932358</p>
<p><b>Cause</b></p>	<p>This may be due to a software anomaly</p>

<p><b>Condition</b></p>	<p>A customer may comment that after using CarPlay their radio has stability issues. These could include:</p> <ul style="list-style-type: none"> <li>• Intermittent blank radio screen with HVAC and vehicle controls still showing</li> <li>• CarPlay audio may stop or disconnect</li> <li>• Rebooting of the radio</li> <li>• Slow to boot – including seeing “Android is Starting” on the radio</li> <li>• Message below about storage space</li> <li>• Performing a factory reset – including losing radio favorites and phone pairings</li> </ul>

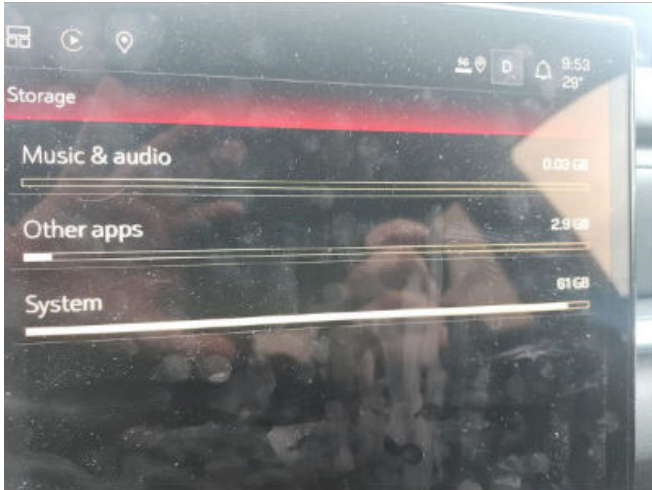
6932357

Check the System memory to see if it is close to full: Settings\System\S

To temporarily recover storage/memory space for the customer, perform a reset using the Steering Wheel Controls:

- 1.1.1) Vehicle must be in Park to reboot your system.
- 1.1.2) Press and hold the END CALL button on steering wheel for about 15 seconds. Until the center screen turns black, then release the END CALL button.
- 1.1.3) After approx. 5-10 seconds, you will see the welcome screen and your infotainment system will reboot itself.
