GENERAL MOTORS  
DCS7232  
URGENT - DISTRIBUTE IMMEDIATELY

Subject: N252503990 - Customer Satisfaction Program  
Oil Plug Seated Improperly

Models: 2025 Cadillac CT5-V Blackwing

## N252503990 Oil Plug Seated Improperly

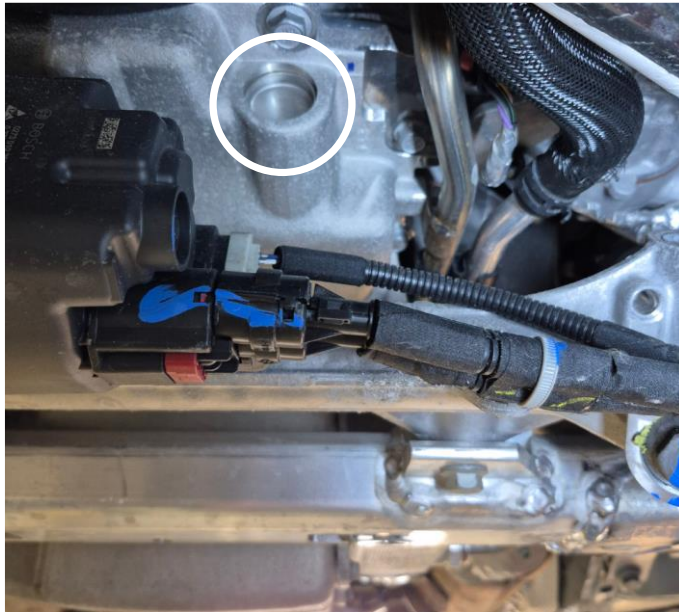
6860566

2. Locate the oil pan pickup tube plug on the front of the oil pan (driver's side) as shown.

1. Remove the Front Cradle Shear Plate. Refer to *Front Cradle Shear Plate Replacement (1SV)* in SI.

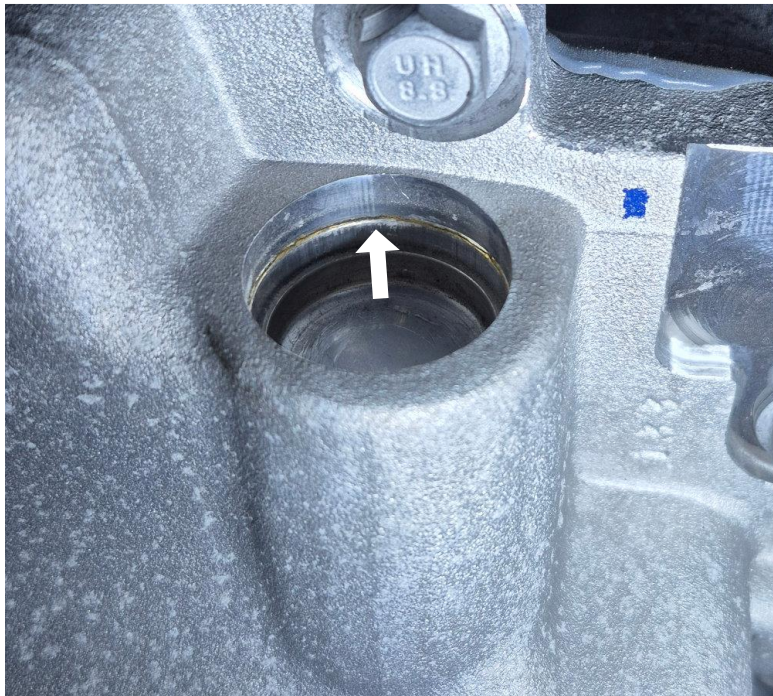
6860567

**IMPORTANT:** The depth to which the plug is pressed beyond the counterbore may vary. As long as the counterbore line is visible as indicated above, no further action is required.

3. Inspect the oil pan pickup tube plug.
  - a. If the plug is pressed to a point where the counterbore line is visible (indicated by white arrow above) no further action is required. Proceed to step 6.
  - b. If the plug is NOT pressed deep enough to expose the counterbore line, proceed to the next step.
