SIB 32 04 25

DIAGNOSTIC HINT: STEERING WHEEL STICKS IN CENTER POSITION

G01 (X3 Sports Activity Vehicle)	G02 (X4 Sports Activity Coupe)	G20 (3 Series Sedan)	G22 (4 Series Coupe)
G23 (4 Series Convertible)	G26 (4 Series Gran Coupe)	G29 (Z4 Roadster)	G42 (2 Series Coupe)

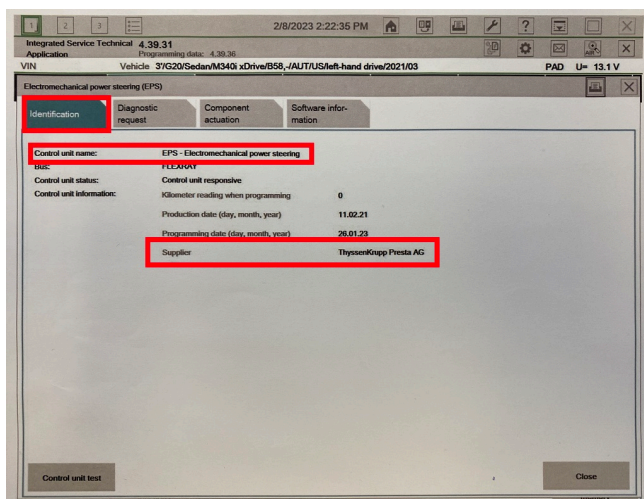
The installed EPS can be identified via ISTA control unit functions.

Use the attached diagnostic troubleshooting steps for the appropriate vehicle and Electric Power Steering (EPS) installed.
