SIB 32 05 25

STEERING COLUMN NOISE AS THE STEERING RETURNS TO THE CENTER POSITION

2025-05-02

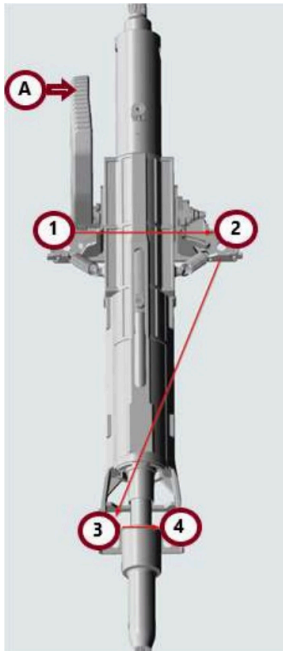
Remove the upper and lower steering column shroud as per REP 32 31 020 to expose the screw connection of the steering column.

- To release the column tension:
1. Loosen all 4 nuts.
 2. Open the adjustment lever (A).
 3. Close the adjustment lever (A).
 4. Tighten the nuts in the defined sequence to 21.4 Nm as shown in the photo to the left.
 5. Continue with installing the lower and upper steering column shrouds.
 6. Reassess the complaint.
