M274 Check engine light, P052E71 Crankcase ventilation valve

Topic number	LI01.20-P-076894
Version	9
Function group	01.20 - Crankcase ventilation, cylinder head cover
Date	5/15/25
Validity	Passenger car with engine M274
Reason for change	Clarify note for op code 010000

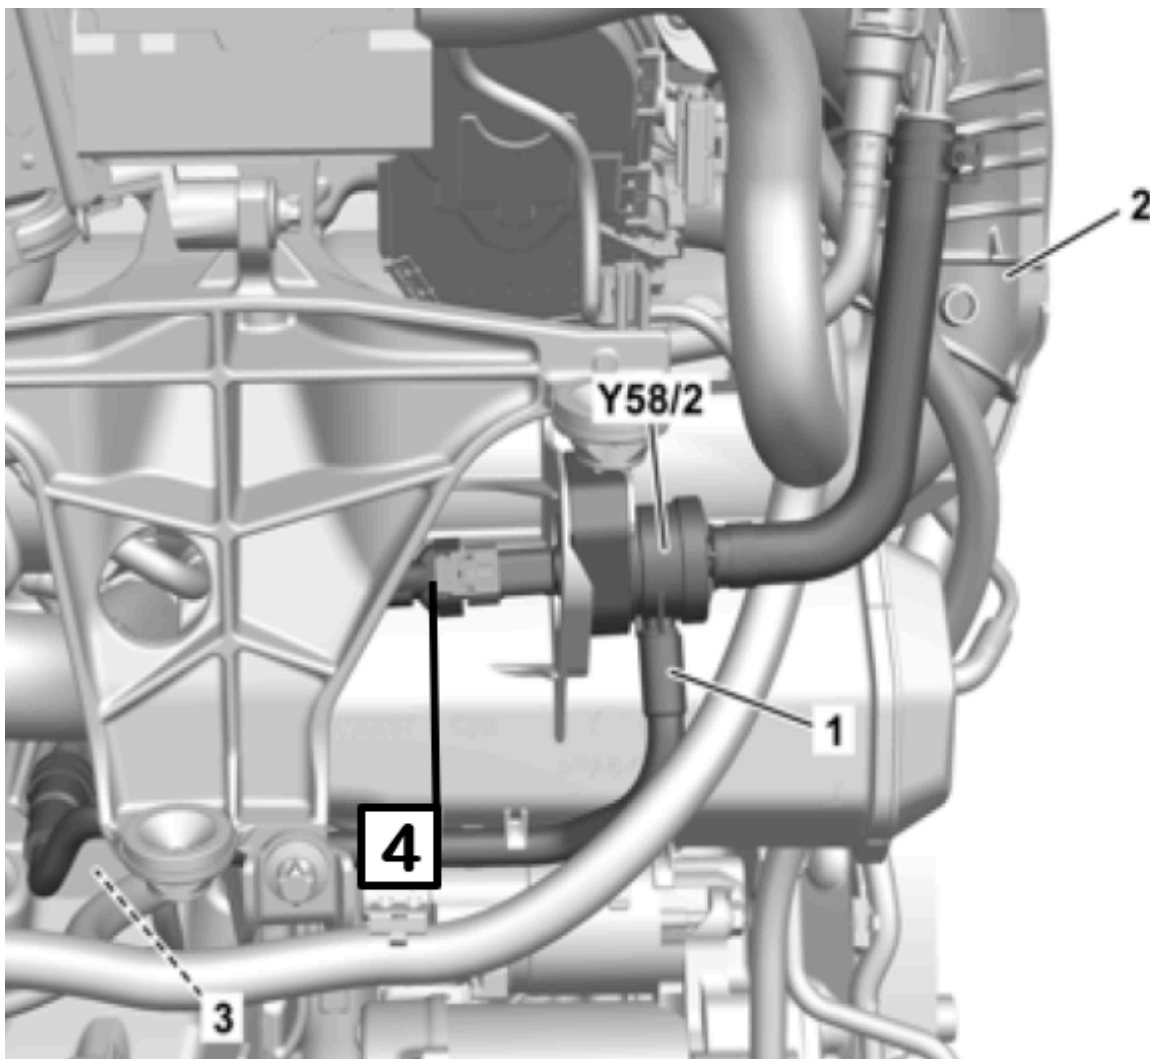
Fault code stored in N3/10 control unit- P052E71 – Positive Crankcase Ventilation Regulator Valve Performance: The valve for crankcase ventilation has a malfunction

The partial-load ventilation valve (a part of the intake line assembly) may not work as intended.

- 1- Perform software update for N3/10 Engine control unit.
- 2- Remove upper engine cover.
- 3- Unclip ME-SFI control unit (N3/10) with bracket and place to one side with connected lines (see AR07.08-P-7013M-RD).
- 4- Release and disconnect electrical connector (4) of partial-load operation crankcase ventilation valve (Y58/2).
- 5- Fit cap A094 545 50 03 on electrical connector (4) of engine wiring harness partial load operation crankcase ventilation valve (Y58/2) and ensure correct seating on plug of electrical connector (4).

6- Strap down electrical line (4) of partial load operation crankcase ventilation system valve (Y58/2) at wiring harness. Ensure that electrical line (4) is routed free of tension.

7- Clip in ME-SFI[ME] control unit (N3/10) with bracket, ensure control unit is correctly seated at attachment points.
