GENERAL MOTORS  
DCS 7225  
URGENT - DISTRIBUTE IMMEDIATELY

Subject: N252503350 - Customer Satisfaction Program  
Unresponsive Virtual Key Modules

Models: 2025 Cadillac LYRIQ

## N252503350 Unresponsive Virtual Key Module

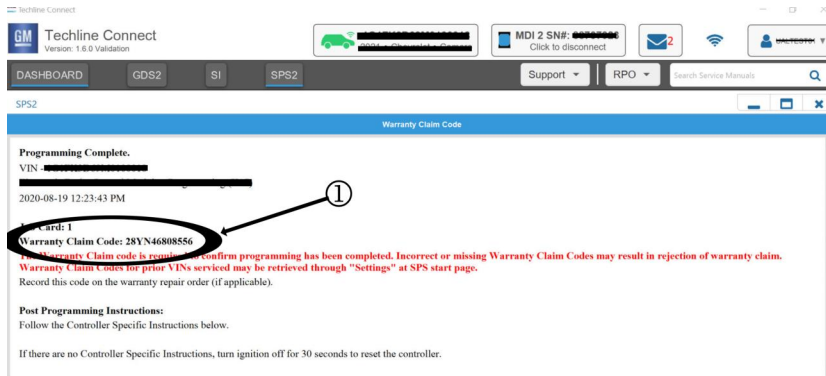
5644478

**Note:** The screenshot above is an example of module programming and may not be indicative of the specific module that is being programmed. Module selection and VIN information have been blacked out.

**Important:** To avoid warranty transaction rejections, you **MUST** record the warranty claim code provided on the Warranty Claim Code (WCC) screen shown above on the job card. Refer to callout 1 above for the location of the WCC on the screen.
