PAC Module Camera Repair

Bulletin Type:	SRP	Publication Date:	May 2025
Bulletin #(s):	25-007	Make(s):	Jayco, Entegra Coach
Job Code(s):	<i>If affected unit has warranty remaining, submit your claim following the normal process</i>	Model(s):	Melbourne, Redhawk, Odyssey, Esteem, Greyhawk
Flat Rate(s):		Model Year(s):	2021 - 2026

Incident:	Radio screen displays "No Camera Input error".
Affected Units:	2021 - 2026 Jayco Melbourne, Redhawk, Greyhawk and 2021 - 2026 Entegra Coach Odyssey, Esteem
Parts List:	N/A
Misc. Tools & Supplies:	N/A

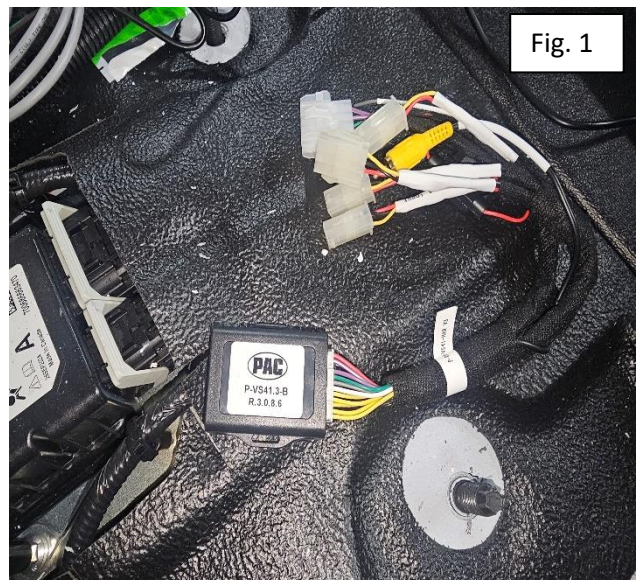
Fig. 1

- Units use a 3-camera input, 1 camera output switcher module. It is made by PAC. It will be a black box with a PAC decal on it. (Figure 1)

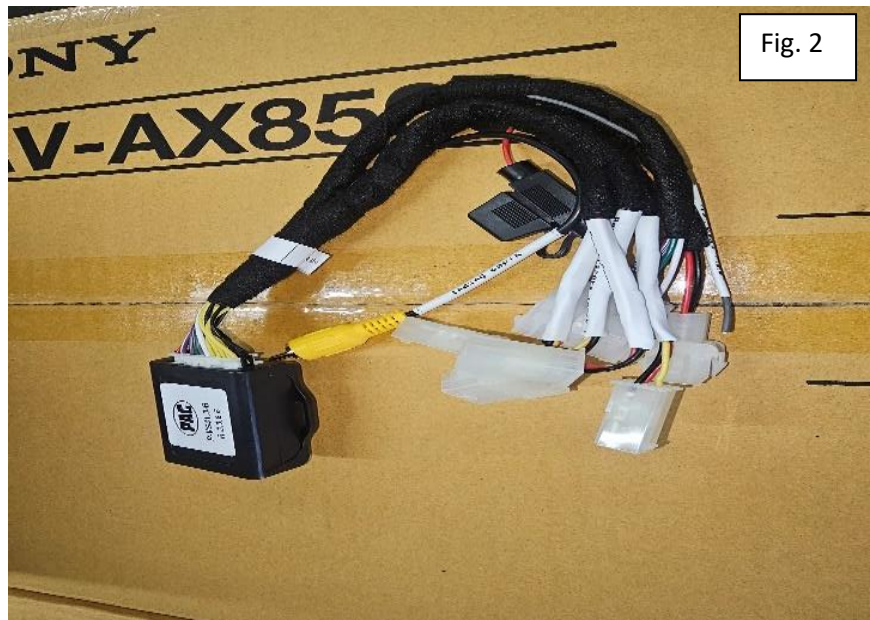
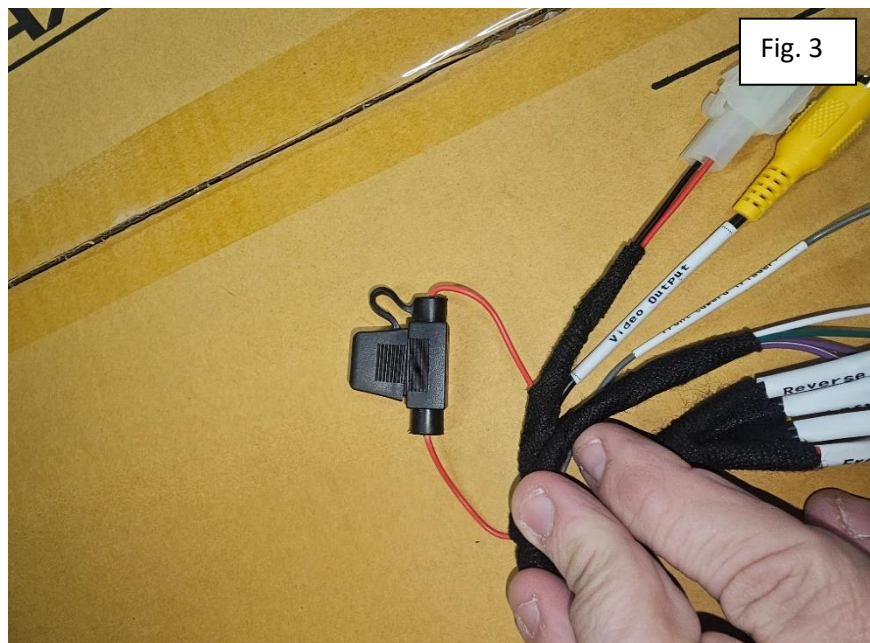
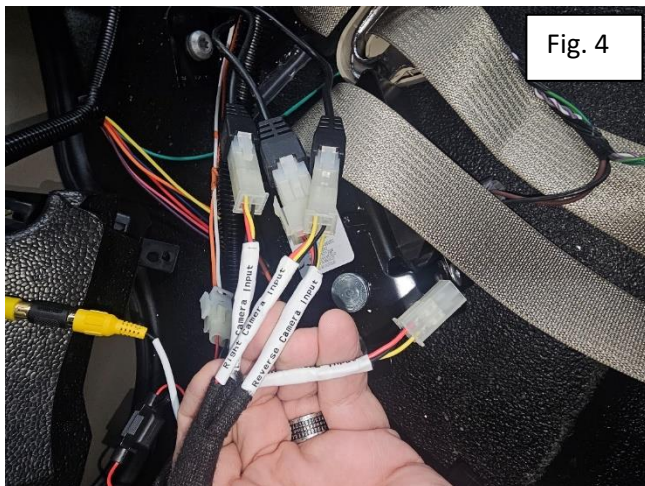
2. PAC module will be tucked up under the dash in the steering column area. Find the inline fuse that is 3-4 inches from the PAC model in the wire harness.
3. The fuse is good if getting a no camera error only on 1 camera. It is either a loose connection on the wire harness at that camera or a bad camera. (Figures 2-5)

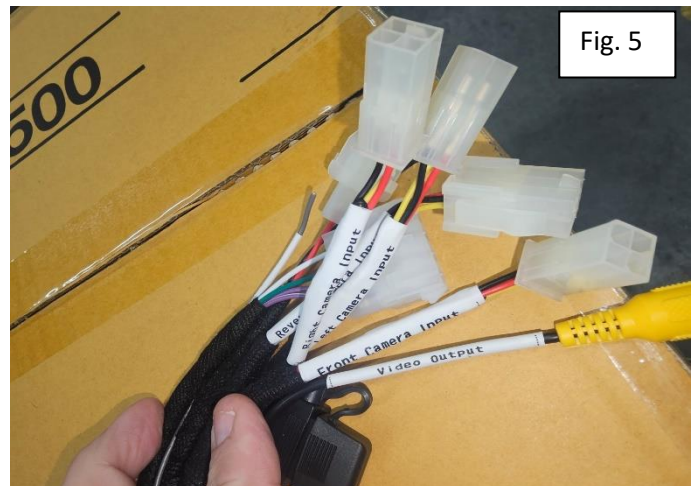
Fig. 5

4. Camera inputs will kind of look like a CAT5 (network cable). They are marked left, right, and rear so it is pretty self-explanatory which is which.
5. That CAT5 connection carries the trigger signal and the video signal. The output of the PAC module is the single yellow RCA connection. (Figures 5-6)
6. The camera signal output will then plug into the wire harness on the back of the radio. (Figure 6)

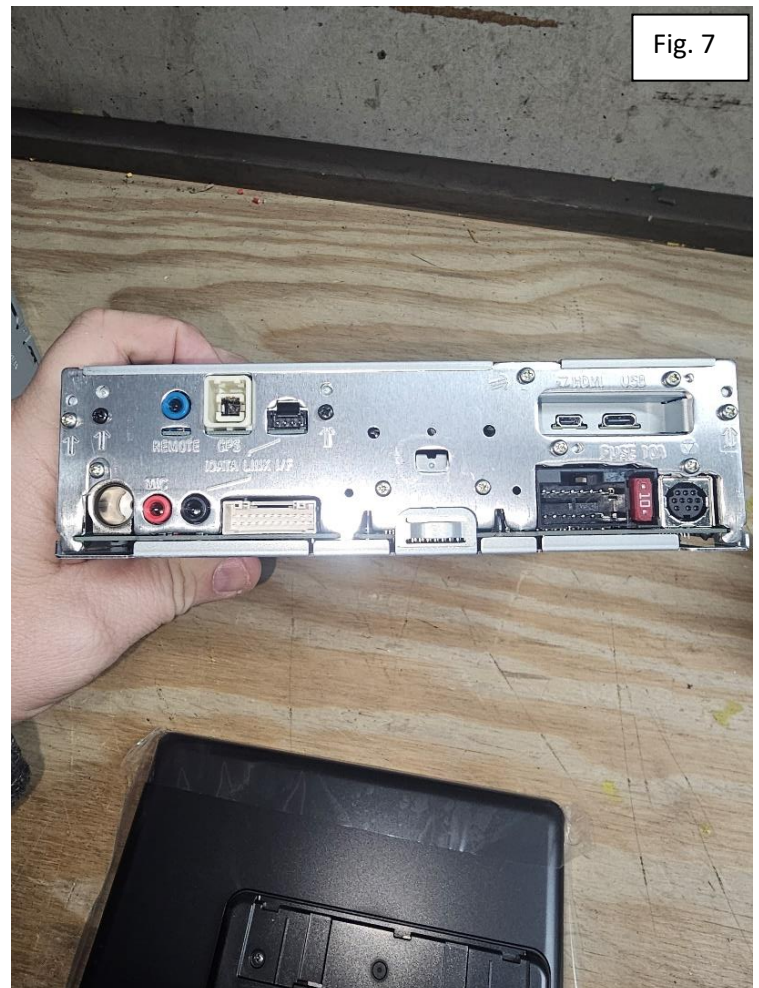
Fig. 7

7. All of the RCA inputs on the radio will plug into a harness that plugs into the big white harness input on the back of the radio. The GPS antenna we install will plug into the white square plug in the upper left marked GPS. The mic we install will plug into the red 3.5 mm MIC port.
8. The USB input for either charging or wired car play or Android auto plugs into the USB C cable that should come out of the top right of the radio AM/FM radio antenna plugs into the circular hole on the lower left. (Figure 7)

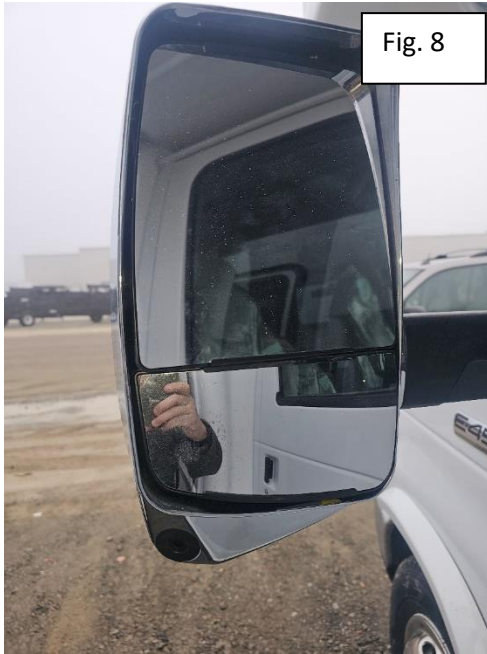
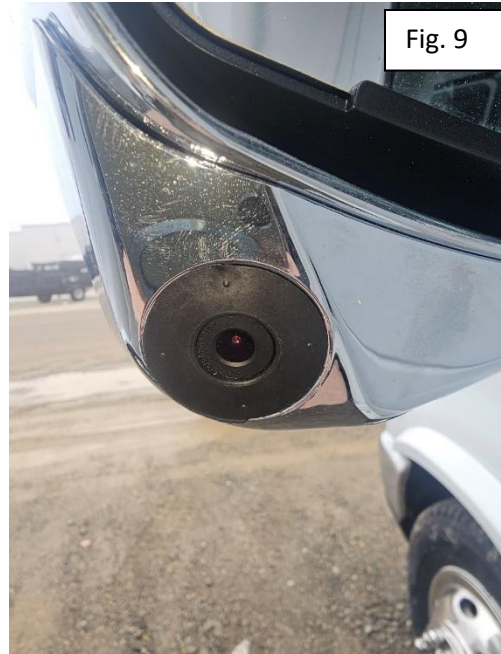
9. Side view mirror with Camera on bottom left of it. (Figures 8-9).
