SIB 66 03 25

## PARKING ASSISTANCE LIMITED CHECK CONTROL MESSAGE DUE TO PDC SENSORS

This Service Information Bulletin (Revision 2) replaces SI B66 03 25 **dated March 26th, 2025.**

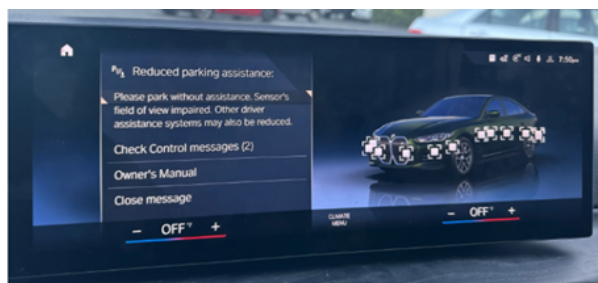
The parking assistance limited check control message can be related to environmental influence, component degradation, or unfavorable UCAP module software

Example photo of check control message Displayed for reduced parking assistance.

If the root cause is not determined to be related to environmental influence (specific locations, roads, etc.), or component failures, reprogram the UCAP module with the required I-level **25-07-510** or higher.

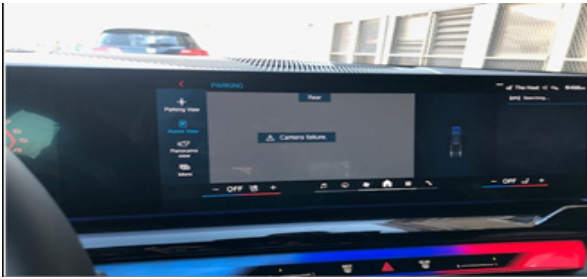
Example photo of camera failure message.
