**SIB 72 01 25****G1X/G3X FALSE ALERT RF SEAT OCCUPIED W BELT UNBUCKLED-EXTENDED LIMITED WARRANTY**

2025-05-01

This Service Information bulletin (Revision 01) supersedes SI B72 01 25 **dated April 2025**

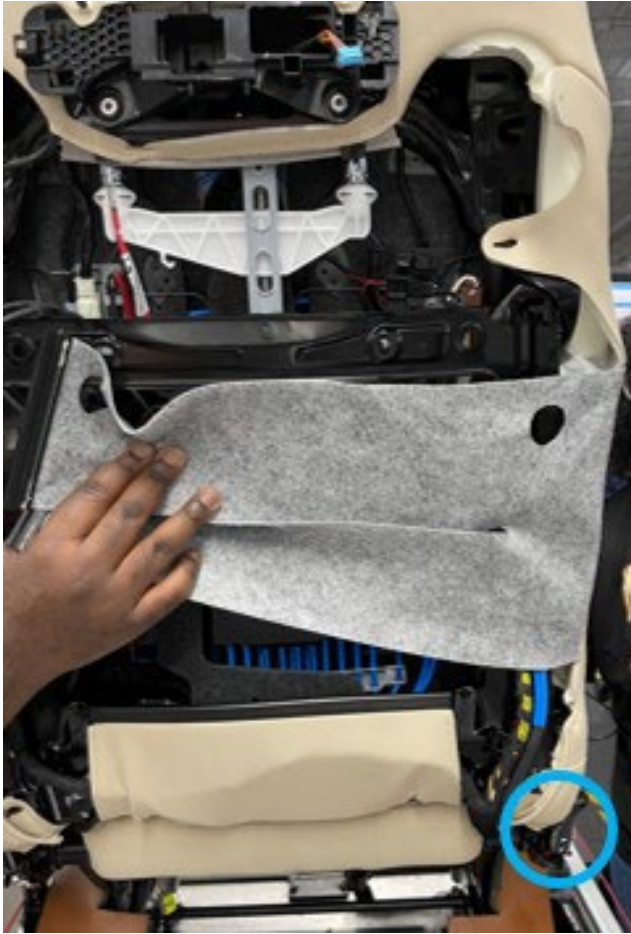
3. Prior to replacing components, inspect the connection of the CIS mat ground wire to the structure at the lower right side of the backrest (circled).

The eyelet on the ground wire should make solid connection to the structure with no free play.

If free play is identified, repair as needed.

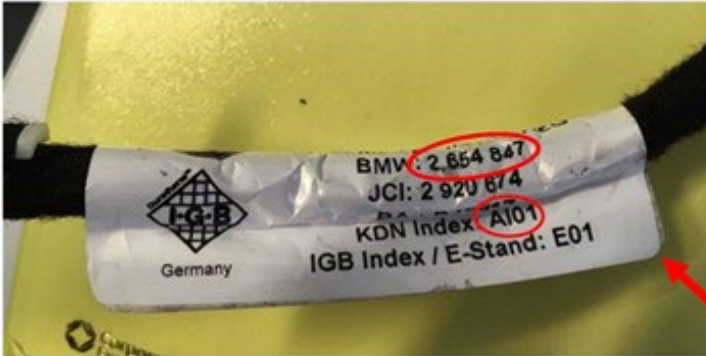
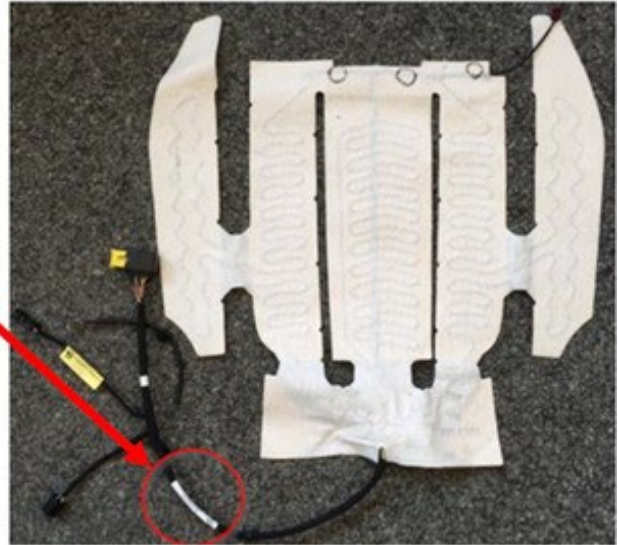
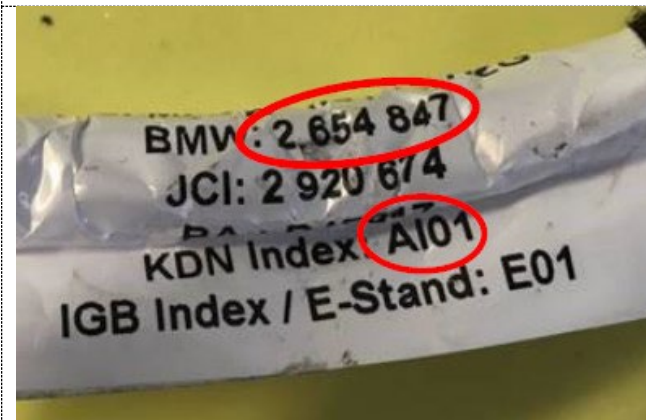
In this example, the BMW Part Number 2 654 847 is shown (circled).

The corresponding KDN (Revision) Index number "AI01" is shown (circled).

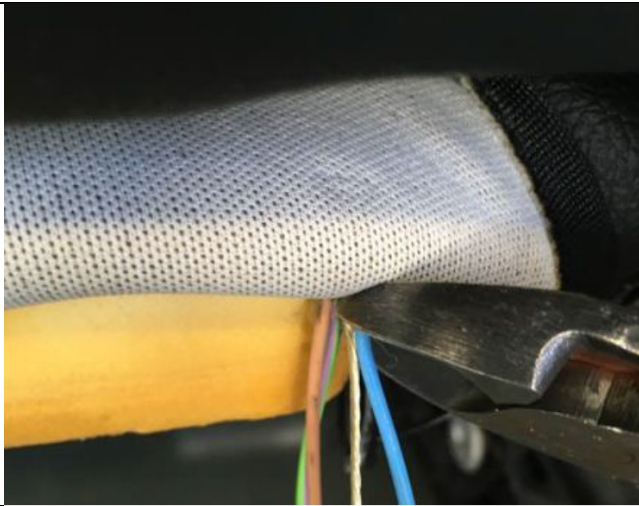
There are 4 wires in the cut cable assembly, but only 2 of which are needed (brown and green/purple).

Cut open the cable assembly 2 centimeters before the seat heating element and remove the rubber jacket.

The other two cables (blue and a cable Without a colored jacket) are no longer needed and can be cut off.
