SIB 72 03 25

## G01/G02 FALSE ALERT RF SEAT OCCUPIED W BELT UNBUCKLED-EXTENDED LIMITED WARRANTY

This Service Information bulletin (Revision 01) supersedes SI B72 03 25 **dated April 2025**

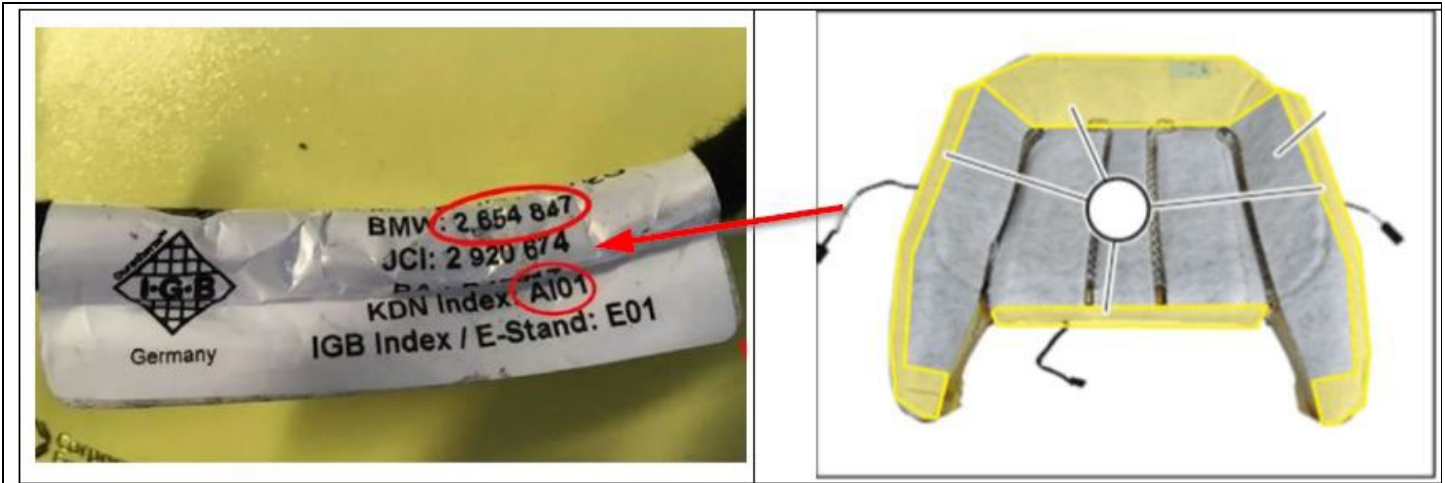
In this example, the **BMW Part Number 2 654 847** is shown (circled).

**The corresponding KDN (Revision) Index number “A101” is shown (circled).**

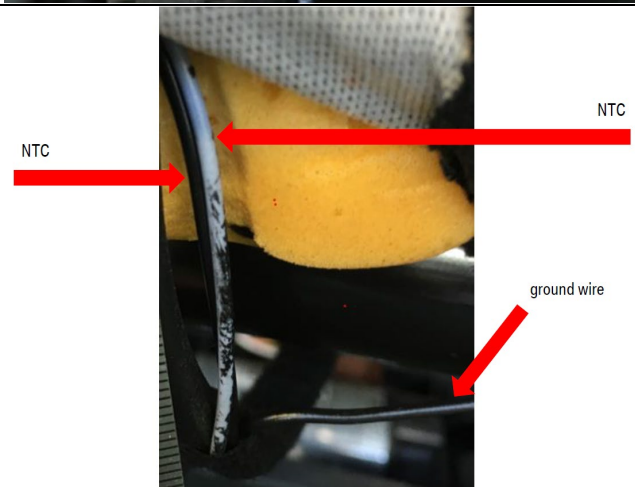
The following cables/cable assemblies are now exposed:

- two NTC cables (negative temperature coefficient lines) for temperature
- Outgoing grounding wire.

**THESE WIRES MUST NOT BE CUT!**

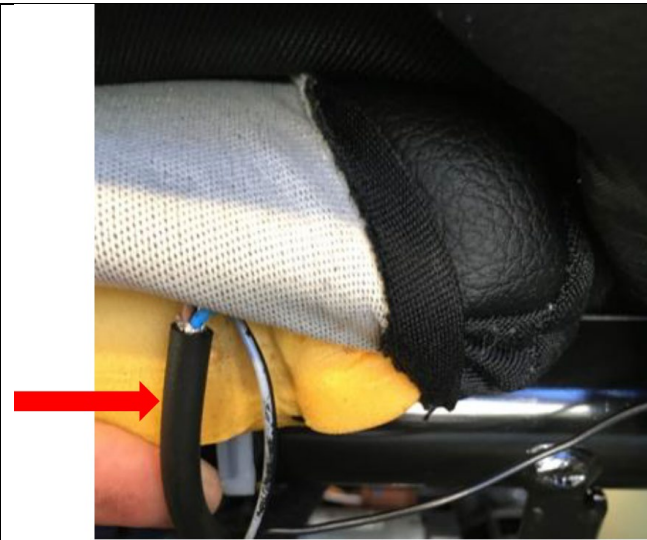
The following cables/cable assemblies are now exposed:

- Cable assembly (4 cables in a rubber jacket) including shielding.

This is the wiring that will be modified

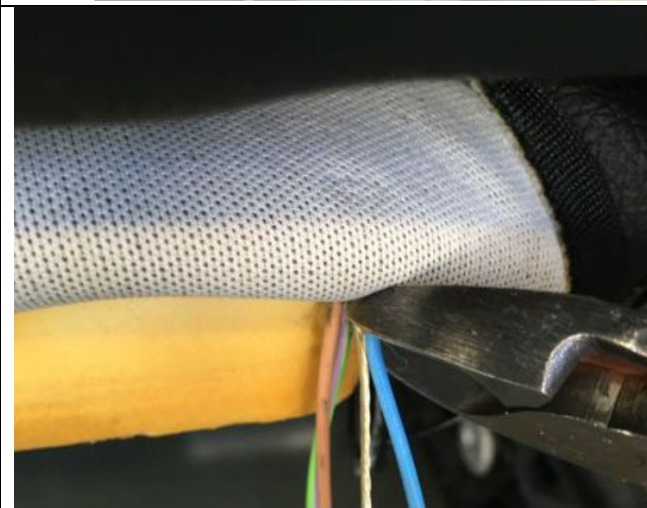
There are 4 wires in the cut cable assembly, but only 2 of which are needed (brown and green/purple).

The other two cables (blue and a cable Without a colored jacket) are no longer needed and can be cut off.

Cut open the cable assembly 2 centimeters before the seat heating element and remove the rubber jacket.
