SIB 01 04 25

G0X/GX0 PHEV HV BATTERY EXPANSION VALVES EXT LTD WTY (ELW)
15 YRS/150,000 MILES

2025-05-19

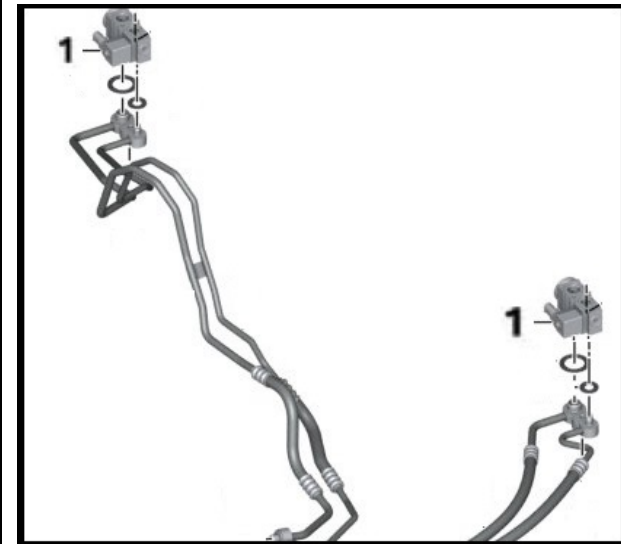
For the eligible vehicle models, BMW of North America, LLC (BMW NA) is extending the limited warranty coverage for the **high-voltage battery assembly's refrigerant circuit expansion valves** to:

The BMW PHEV's high-voltage battery assembly's refrigerant circuits expansion valves, one or both, may fail.

For example, if the high-voltage battery assembly's refrigerant circuit' expansion valve remains permanently "open," the cooling system's target temperature "set point" will remain at permanent cooling.

When a vehicle arrives with the issue described in the CAUSE, perform the corresponding diagnosis and when applicable, replace the affected high-voltage battery refrigerant circuit's expansion valve as instructed, or as determined by the diagnosis.
