SIB 37 02 25

DELIVERY STOP: AIR SUPPLY SYSTEM LINES

E-Series	Model Description	Production Date
G05	X5 Sports Activity Vehicle	April 4, 2025
G06	X6 Sports Activity Coupe	April 4, 2025
G07	X7 Sports Activity Vehicle	April 4, 2025

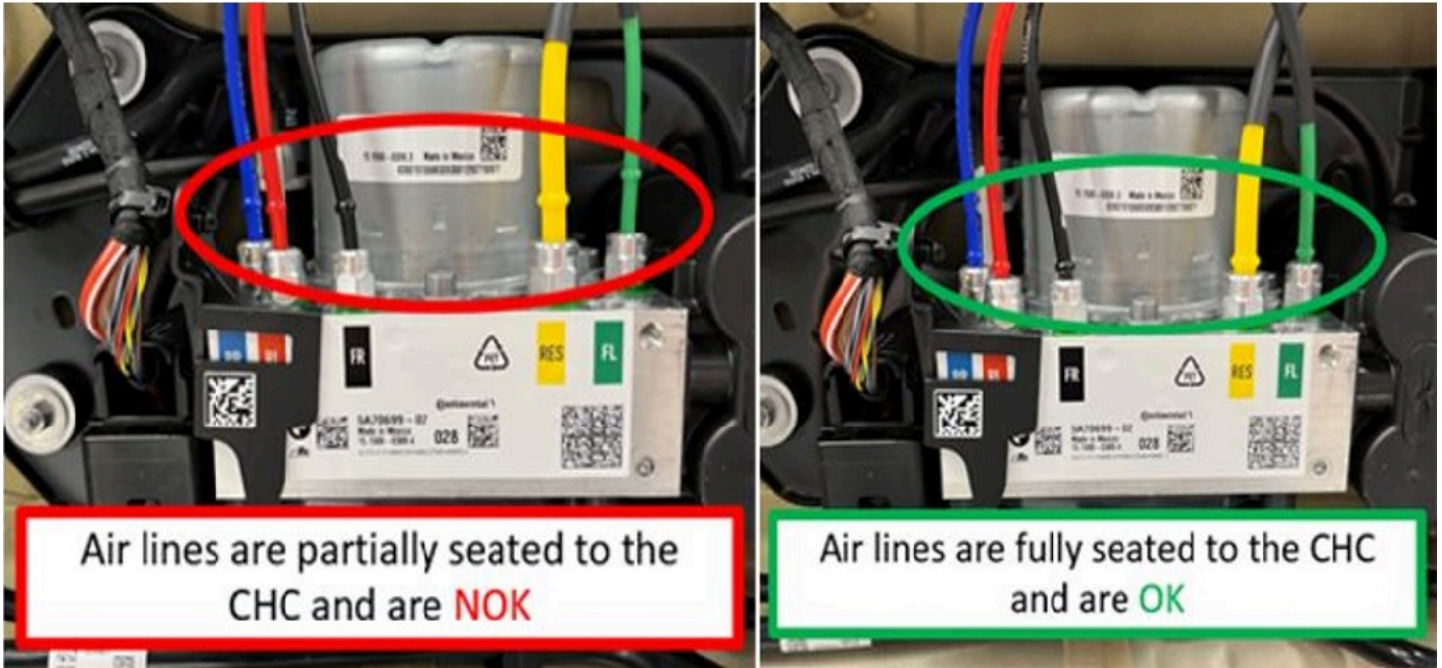
The air line on the air suspension supply system may not be properly installed. In the event of a fault, residual pressure is maintained in the struts and corresponding check control message.

Assembly error during the air system installation.

Check the air lines on the air supply system and, if necessary, fit them into the correct position
