**SIB 64 05 25**

**HVAC FLAP LINKAGE NOT FULLY CONNECTED**

<b>E-Series</b>	<b>Model Description</b>	
G45	X3 Sports Activity Vehicle

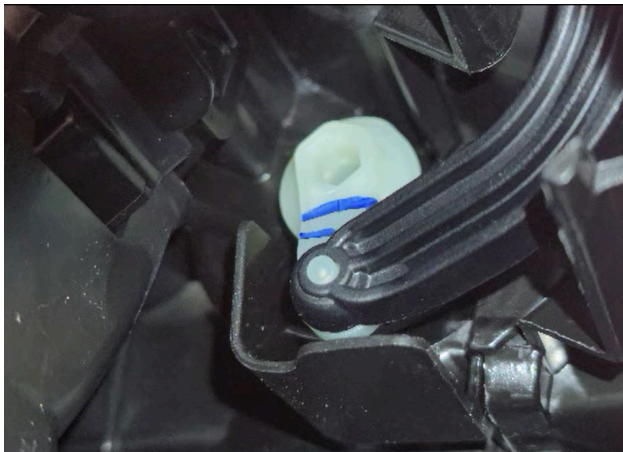
Check that the linkage has not come loose from the HVAC flap for the zone that is malfunctioning.

There is a white plastic mechanism that connects the black linkage arm and the HVAC flap assembly.

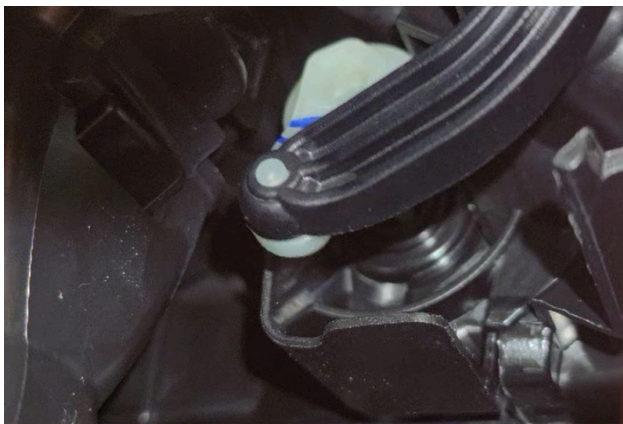
To test if the mechanism is fully seated into the HVAC flap assembly, perform a wiggle test of the white plastic (in/out). Here you can see the white plastic mechanism has backed out of the HVAC case and is not locked into the flap.

There is a push in end on the linkage that can be reinserted into the HVAC flap and fully seated. The white plastic mechanism push pin can be reinserted into the HVAC flap and fully seated.

**Make sure to push in until you can feel the white plastic mechanism push pin mushroom shaped end engage into the flap ramp.**

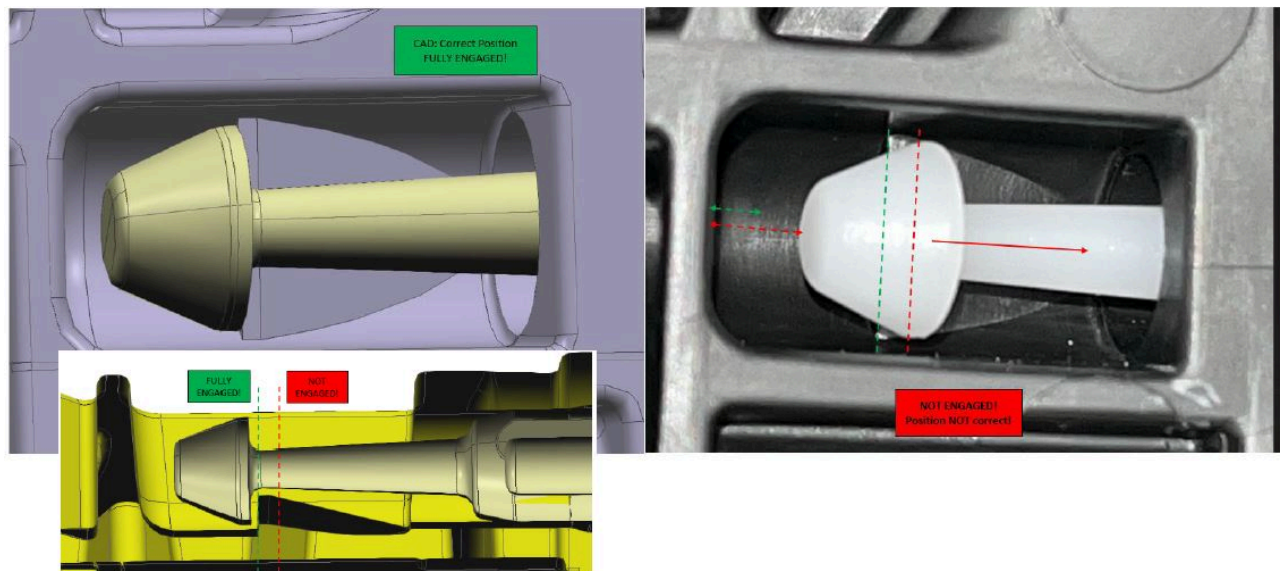
If using a borescope to inspect if the flap is fully locked into the linkage, you can see the White plastic mechanism push pin mushroom shaped end must engage into the flap by being pushed in until it fully goes past the plastic flap ramp. The pictures below show fully locked in vs not fully locked.
