# Technical Service Bulletin

| <b>BODY</b> | <b>25-BD-005G</b> |
| <b>MAY 2025</b> | <b>GV60 (JW1 EV)<br/>GV80 (JX1)</b> |

**SUBJECT:** TAILGATE RATTLE NOISE REPAIR

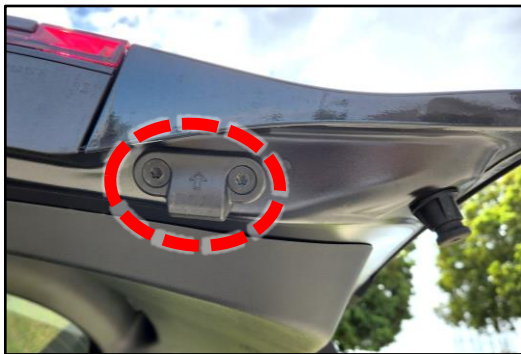
**Description:** Certain GV60 (JW1 EV) and GV80 (JX1) vehicles may experience a rattle noise from the tailgate side panel or side outer panel area while driving. This bulletin provides instructions to install washers to the side guide bumpers on the tailgate side panel or body panel.

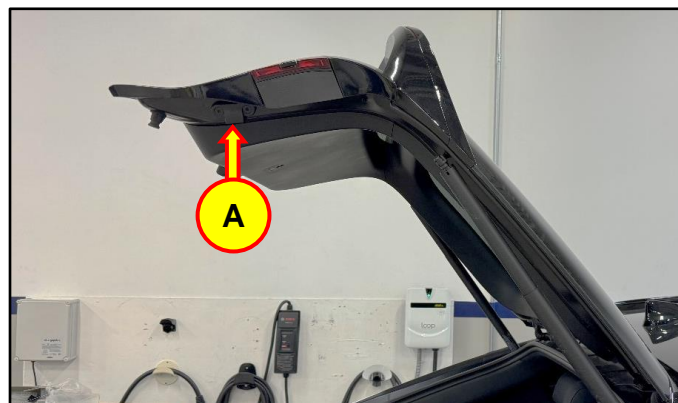
1. Open the tailgate and locate the tailgate side guide bumper (A).

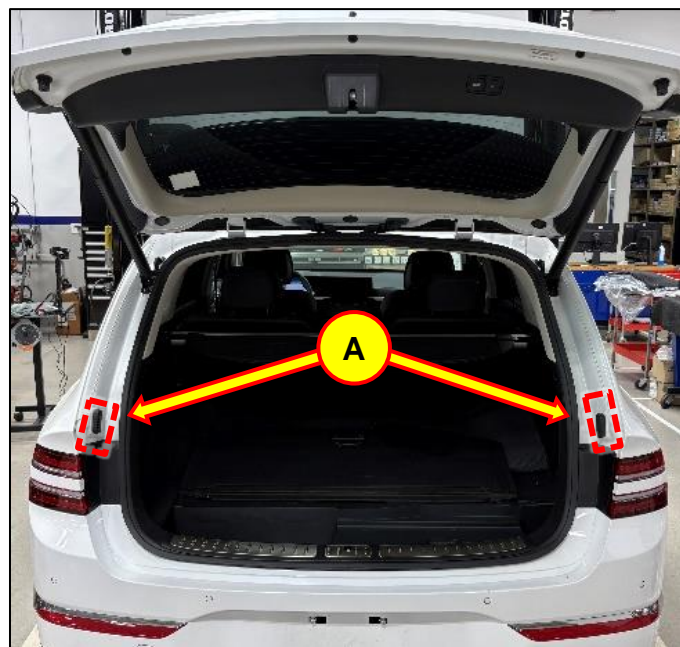
- 1. Open the tailgate and locate the body side guide bumpers (A).
