TECHNICAL SERVICE BULLETIN

Click/Pop Noise While Turning The Steering Wheel From Straight Ahead To Full Lock During Low Speed Turning Events

25-2213
20 May 2025

| Ford 2020-2025 Explorer | Built On Or Before 28-Jan-2025 |

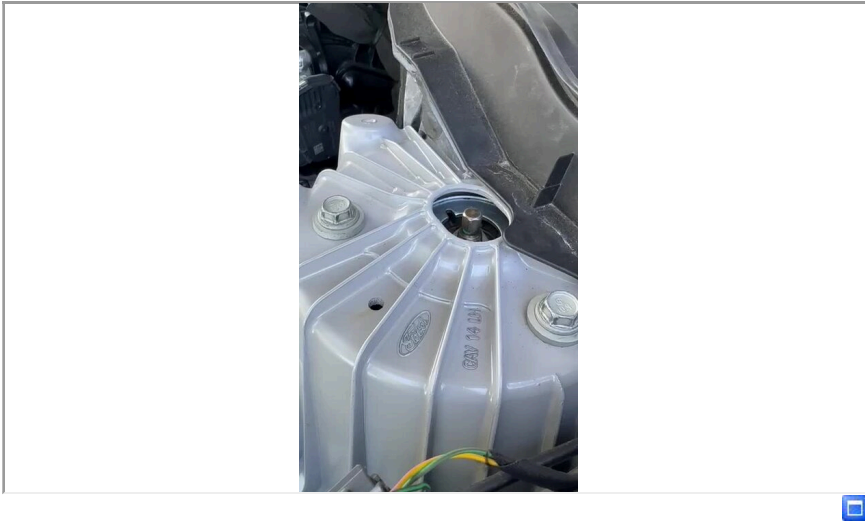
Issue: Some of the vehicles listed in the Model statement above may exhibit a click/pop noise while turning the steering wheel from straight ahead to full lock during low speed turning events. This noise may be due to front upper strut mount washer movement under steering loads.

Refer to this video for an example of the condition:

1. With vehicle on the ground and engine running, turn the steering wheel from straight ahead to full lock in both directions. Compare with the video example above. Is movement seen and/or click/pop noises heard from the front upper strut mount(s)?
 - (1). Yes - proceed to Step 2.
 - (2). No - this article does not apply. Refer to [WSM](#), Section 204-01B for further diagnosis.
2. Remove the front strut and spring assembly on the affected side(s). Refer to [WSM](#), Section 204-01B.
3. Disassemble the front strut and spring assembly on the affected side(s). Refer to [WSM](#), Section 204-01B.
4. Replace the front upper strut mount(s).
5. Reassemble and install the front strut and spring assembly/assemblies, as applicable. Refer to [WSM](#), Section 204-01B.
