# TECHNICAL SERVICE BULLETIN

## Wind Noise From Hard Top Front Panel Seal

**25-2219**

Ford 2024-2025 Bronco
--------------------------

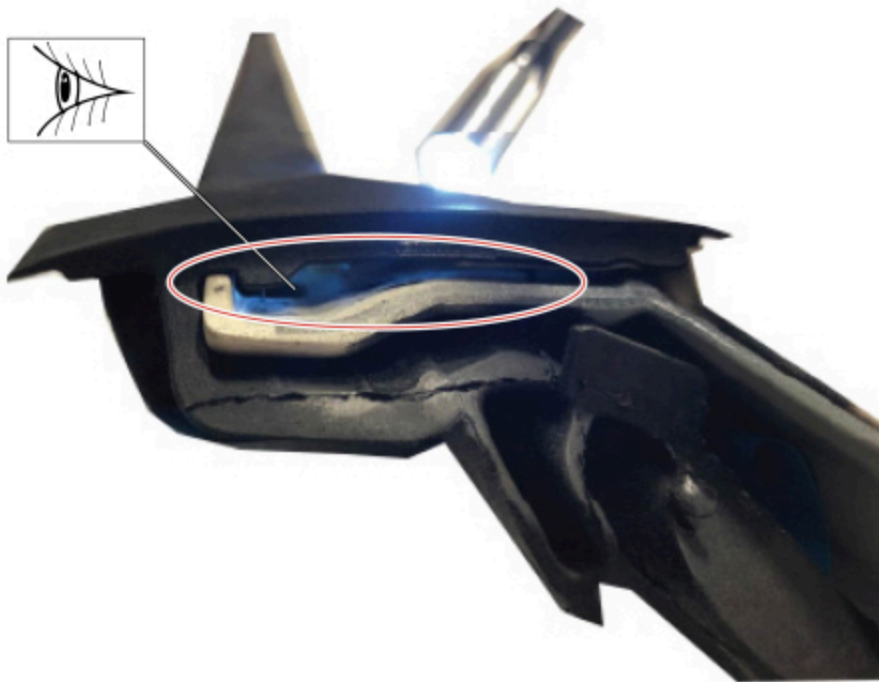
Figure 1

1. Remove the passenger hard top front panel. Refer to WSM, Section 501-18B.
2. Using a flashlight, inspect the seal to hard top panel interface. Is there light visible? (Figures 1-2)
  - (1). Yes - proceed to Step 3. (Figure 1)

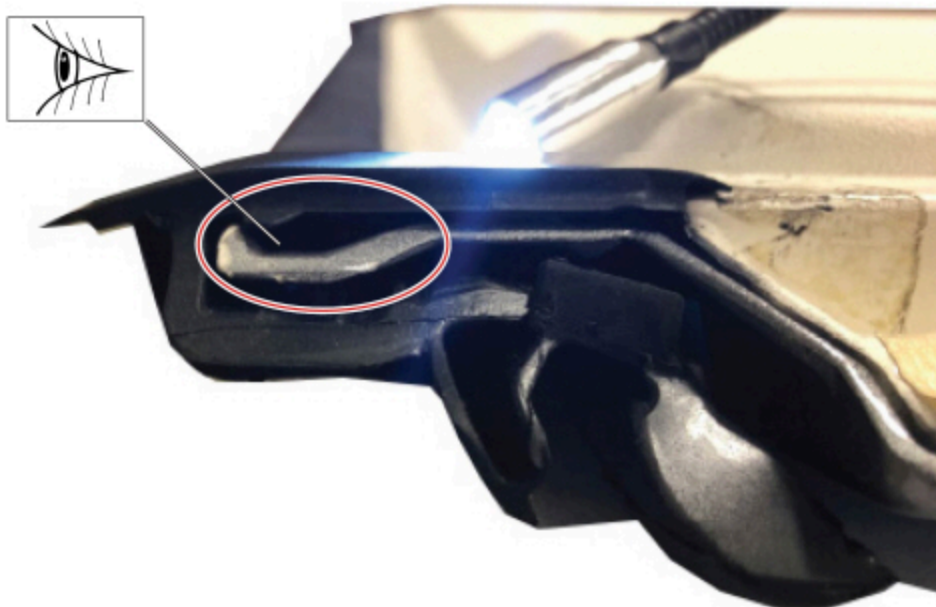
Figure 2

(2). No - this article does not apply. Refer to WSM for normal diagnostics. (Figure 2)
