## "SOS - Service not activated" Message In The Instrument Cluster After Software Update Of HERMES N112/9 In Gray Import Vehicles

Topic number	LI82.85-P-079271
Version	1
Function group	82.85 - Navigation and Communication systems
Date	5/22/25
Validity	Vehicles with HERMES communications module (code 360, 362 or 364).
Reason for change	New version of "How-to request adding...."

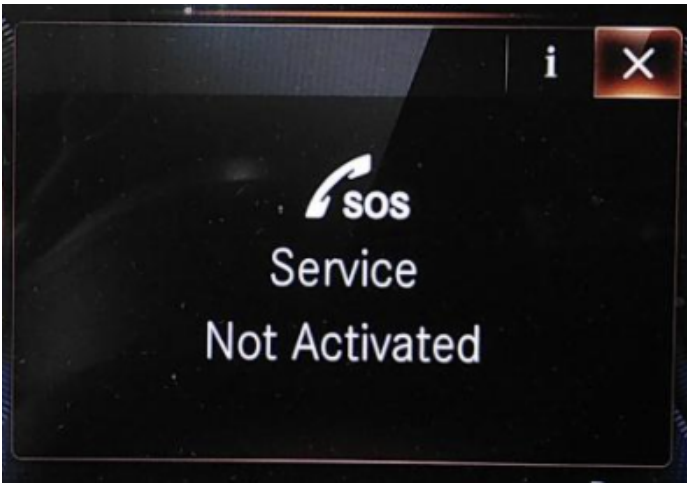
Attachments	
File	Description
SOS - Service Not Activated.PNG

After a software update of HERMES communication module N112/9 has been performed on a gray import vehicle, the message "SOS - Service not activated" is displayed in the instrument cluster.

The message "SOS - Service not activated" tells the customer that "over-the-air" registration of the vehicle with the Mercedes Intelligent Cloud is not possible.

On a gray import vehicle, this is due to the fact that the SIM card installed in the HERMES communications module cannot dial into the mobile phone network in the importing country.

The only way of avoiding the message in the instrument cluster is to deactivate the HERMES module using the 09o deactivation process after obtaining the customer's consent.
