Service Bulletin

Bulletin No.: PIP6064

Subject: LZ0 Multiple DTCs Due to Melted Harness

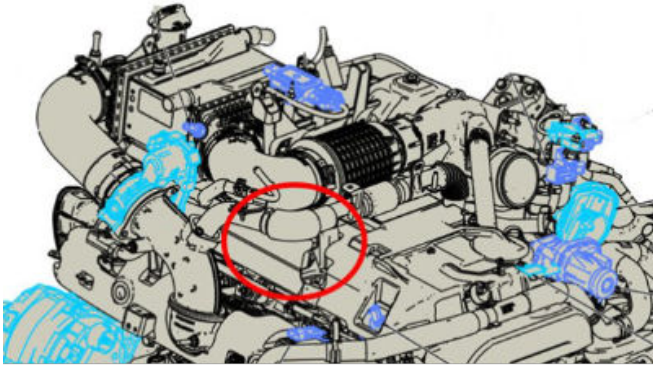
6927354

Involved Region or Country	North America
Condition	MIL on with any of the following DTCs set in the ECM: B2AEF, P00EA, P00EB, P00EC, P01BB, P01BC, P01BD, P0202, P0203, P0204, P0206, P0264, P0265, P0267, P0268, P0270, P0271, P0276, P0277, P0335, P0403, P0405, P0406, P045A, P045C, P045D, P0489, P0490, P0651, P0685, P0686, P0690, P0960, P0962, P103B, P103C, P1249, P124A, P124B, P124D, P1682, P16A7, P16B3, P16BC, P16BD, P17F5, P17F6, P17F7, P17FA, P17FB, P17FC, P2053, P2147, P2148, P2150, P2151, P2153, P2154, P2156, P2157, P216B, P216C, P217B, P217C, P217E, P217F, P2381, P2382, P2384, P2564, P2565, U1608, U1609, U160C, U1610, U1611, U1615, U1617, U1639, U163D, U1643, U1647, U1659, U165A, U1818 and/or P0641.
Cause	This may be caused by a damaged wire harness that has come into contact with the EGR cooler outlet pipe or the duct bracket.

If you have any of the above DTCs, check the harness for damaged in the area indicated in the picture below. Repair as necessary and secure the harness to prevent repeat damage.
