Service Bulletin

Bulletin No.: PIT6324A

Subject: Click/Tick/Or Creak Noise Coming From Headliner Near Any Portion Around The Perimeter On The Sunroof Opening

Brand:	Model:	Model Year:		VIN:		Engine:	Transmission:
		from	to	from	to		
Cadillac	Escalade IQ	2025		All	All	All	All

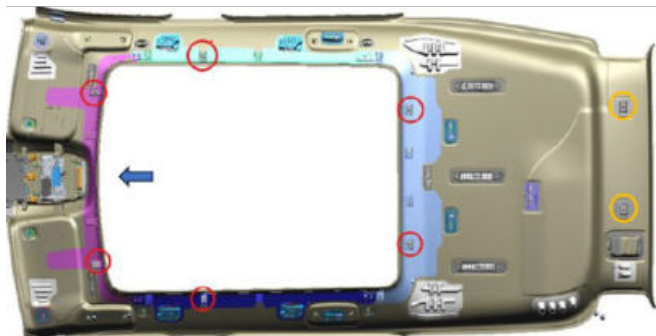
6814516

Involved Region or Country	North America
Condition	Customers may state that there is noise coming from the headliner over various road surfaces. The noise may be anywhere around the perimeter of the sunroof opening.
Cause	Headliner retainer clip that is not fully seated, or an incorrect clip.

The illustration below details the 8 headliner clips (In red) that could cause the noise. Do not use extra clips in the other locations even though it may appear they are missing. The other locations are not designed nor intended for a clip.

Once the suspect area is narrowed down, confirm that the clip is engaged to the sheet metal by shining a flashlight in the glass roof to see a reflection of the clip, it should be engaged to the metal slot. If clip is not engaged, press up on the headliner to engage clip. This should stop the creak noise.

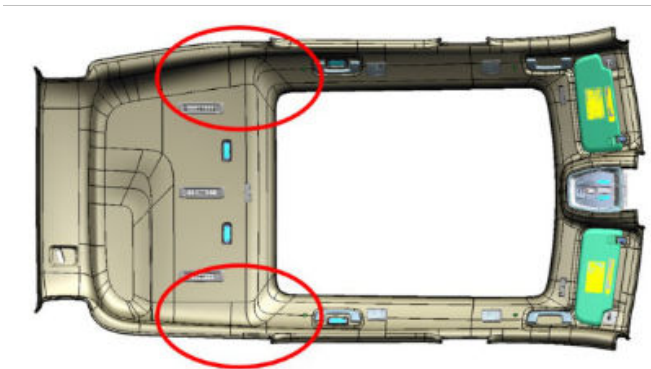
6814517

Caution: When inspecting the clips, the areas circled in red are easily creased if mis-handled while lowering the headliner. See Picture below. Take extra caution not to crease these areas causing permanent damage to the headliner.
