Service Bulletin

Bulletin No.: PIT5966E

Subject: OTA Failure or Download Will Not Complete

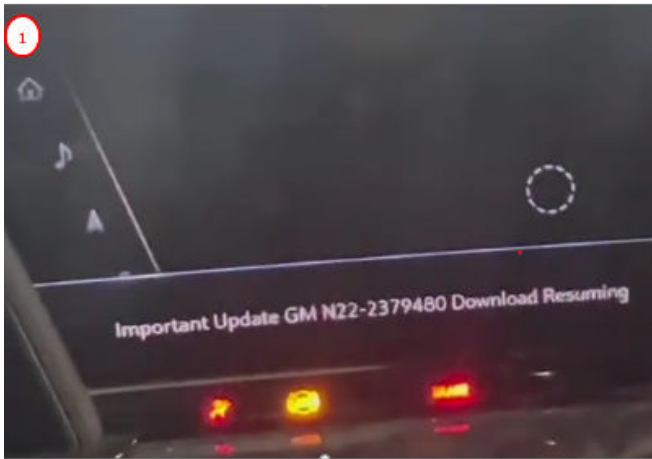
6225208

Cause	The cause of these concerns could be an OTA is stuck in a pending or download state.
