REFERENCE:	TSB: 08-117-25 REV. A GROUP: 08 - Electrical	Date:	May 20, 2025	REVISION:	08-117-25
VEHICLES AFFECTED:	2025 (DT) RAM 1500 Pickup This bulletin applies to vehicles equipped with Smartphone As A Key Capable (Sales Code GX6).	MARKET APPLICABILITY:			
		<input checked="" type="checkbox"/> NA <input type="checkbox"/> MEA <input type="checkbox"/> SA <input type="checkbox"/> IAP <input type="checkbox"/> EE <input type="checkbox"/> CH			
CUSTOMER SYMPTOM:	Software Enhancements included: <ul style="list-style-type: none"> • **Removes keyless sharing.** • Apply Owner Pairing and Key Sharing. • Passive Entry and Passive Start Features. • Improve NFC entry timing from sleep state. 				
CAUSE:	SPAAK Software

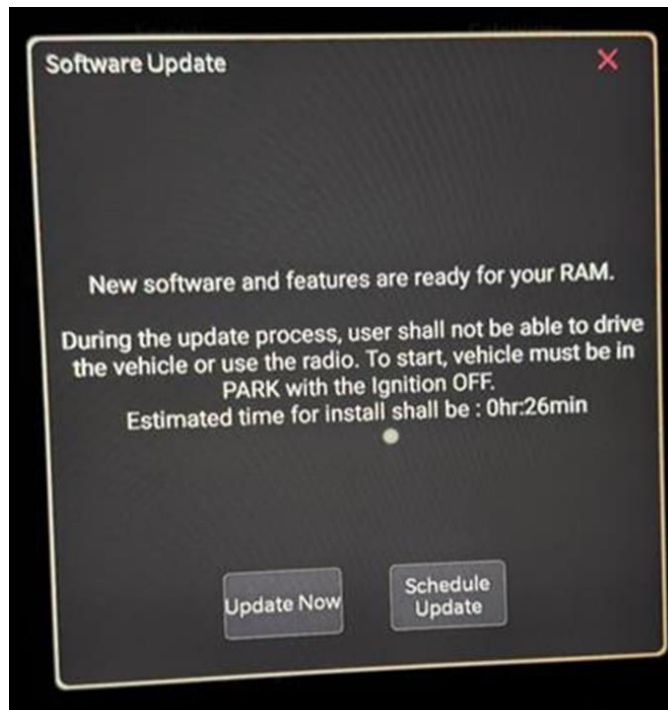
Fig. 1
Software Update Acceptance Screen

1. The vehicle needs to be in 'Park'. The ignition needs to be in the off position [Fig. 1](#), [Fig. 2](#).

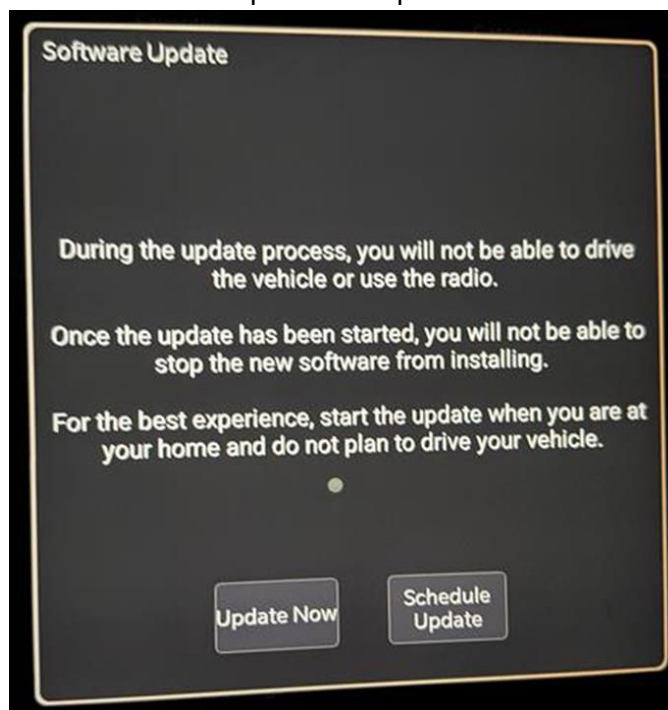
Fig. 2
Software Update In Progress

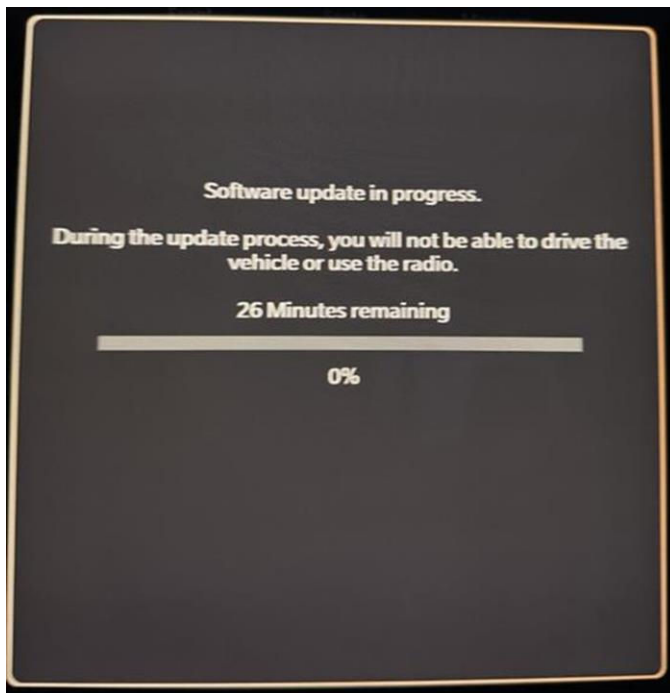
Fig. 3
Software Update In Progress

3. Allow 26 minutes for the update to download [Fig. 3](#).

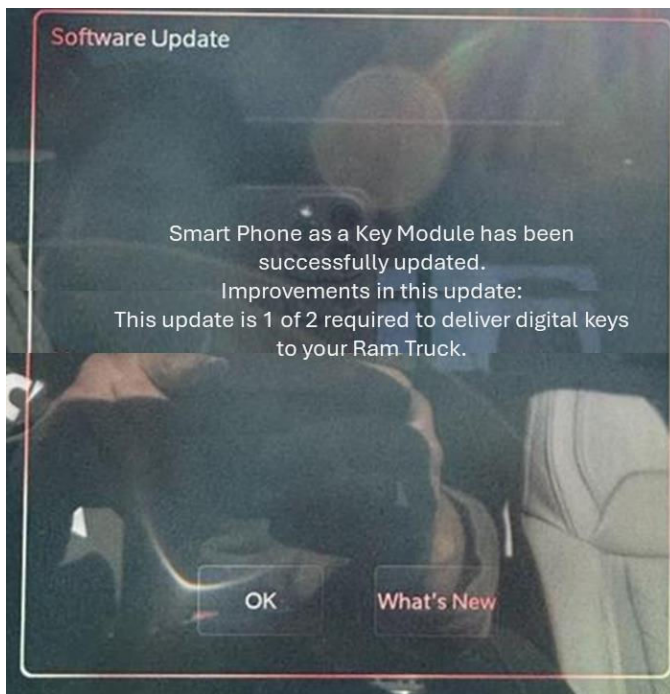
Fig. 4
Software Update Complete

4. Upon completion of update, the radio display will display a confirmation message [Fig. 4](#).
