**Technical Service Bulletin (TSB)**  
**R1H Radio Over The Air Update from T27.46  
to U29.44 then U35.26 Software Version (FOTA)**

<b>REFERENCE:</b>	<b>TSB:</b> 08-157-25 REV. A <b>GROUP:</b> 08 - Electrical	<b>Date:</b>	May 24, 2025	<b>REVISION:</b>	08-157-25						
<b>VEHICLES AFFECTED:</b>	<b>2023 - 2024 (DT) RAM 1500 Pickup</b> <b>This bulletin applies to vehicles equipped with a Global Telematics Box Module (Sales Code RDG) and without IP Badge "TRX" (Sales Code XHD) and one of the following radios:</b> <ul style="list-style-type: none"> <li>● Uconnect 5 Nav w 8.4" Display (USA) (Sales Codes UBL).</li> <li>● Uconnect 5 Nav w 8.4" Display (CAN) (Sales Codes UEL).</li> <li>● Uconnect 5 Nav w 12.0" Display (USA) (Sales Code UBQ).</li> <li>● Uconnect 5 Nav W 12.0" Display (CAN) (Sales Code UEQ).</li> <li>● Uconnect 5 NAV W 14.4" Display (USA) (Sales Code UBW).</li> <li>● Uconnect 5 NAV W 14.4" Display (CAN) (Sales Code UEW).</li> </ul>			<b>MARKET APPLICABILITY:</b>

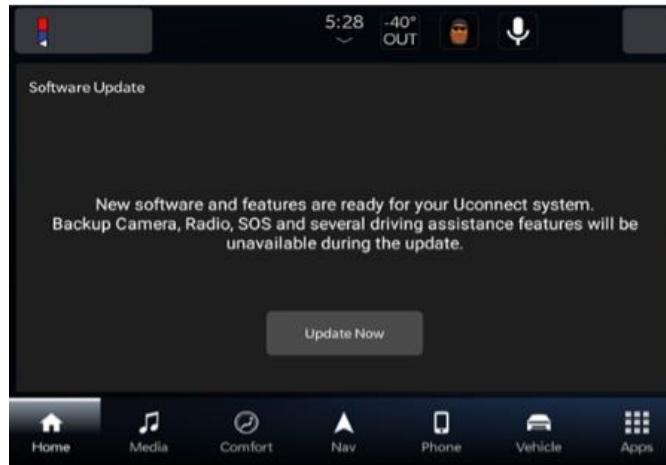
**Fig. 1**

Software Update Screen

1. The vehicle needs to be in ‘Park’ and the ignition in the off position.
2. If the customer selects “Update Now” they can shut off the vehicle and leave. The update will be completed automatically [Fig. 1](#).

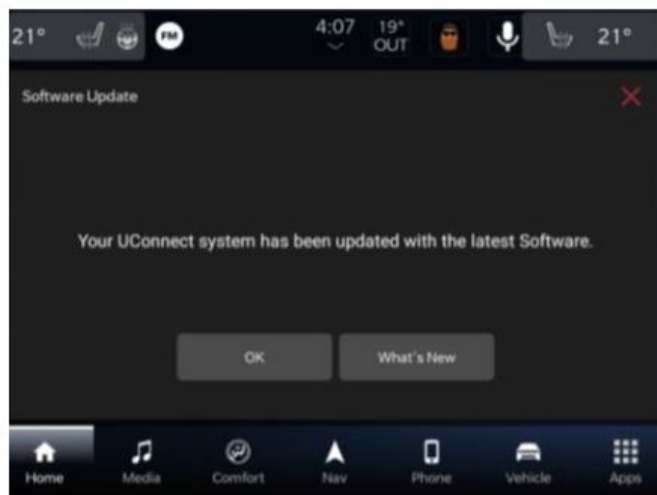
**Fig. 2**

Software Update Confirmation Screen

3. Upon completion of update, the radio will display a confirmation message [Fig. 2](#).
